WINGS BENEATH THE SEA:
the aviation archaeology of Catalina flying boats in Darwin Harbour,
Northern Territory

Thesis submitted for the degree of Master of Arts in the
Faculty of Law, Business and Arts
Northern Territory University
2001

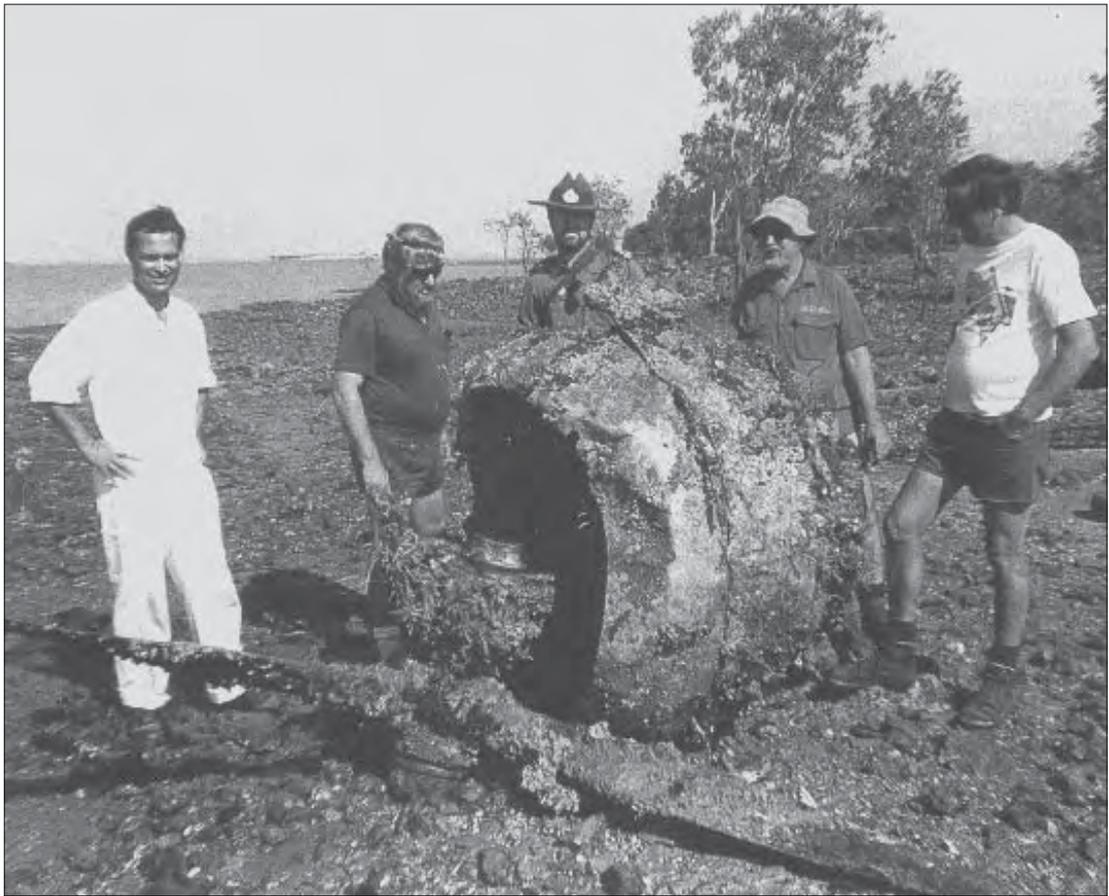
Photo 1. A engine and propeller recovered off Catalina 2 (Candler 1994:2).

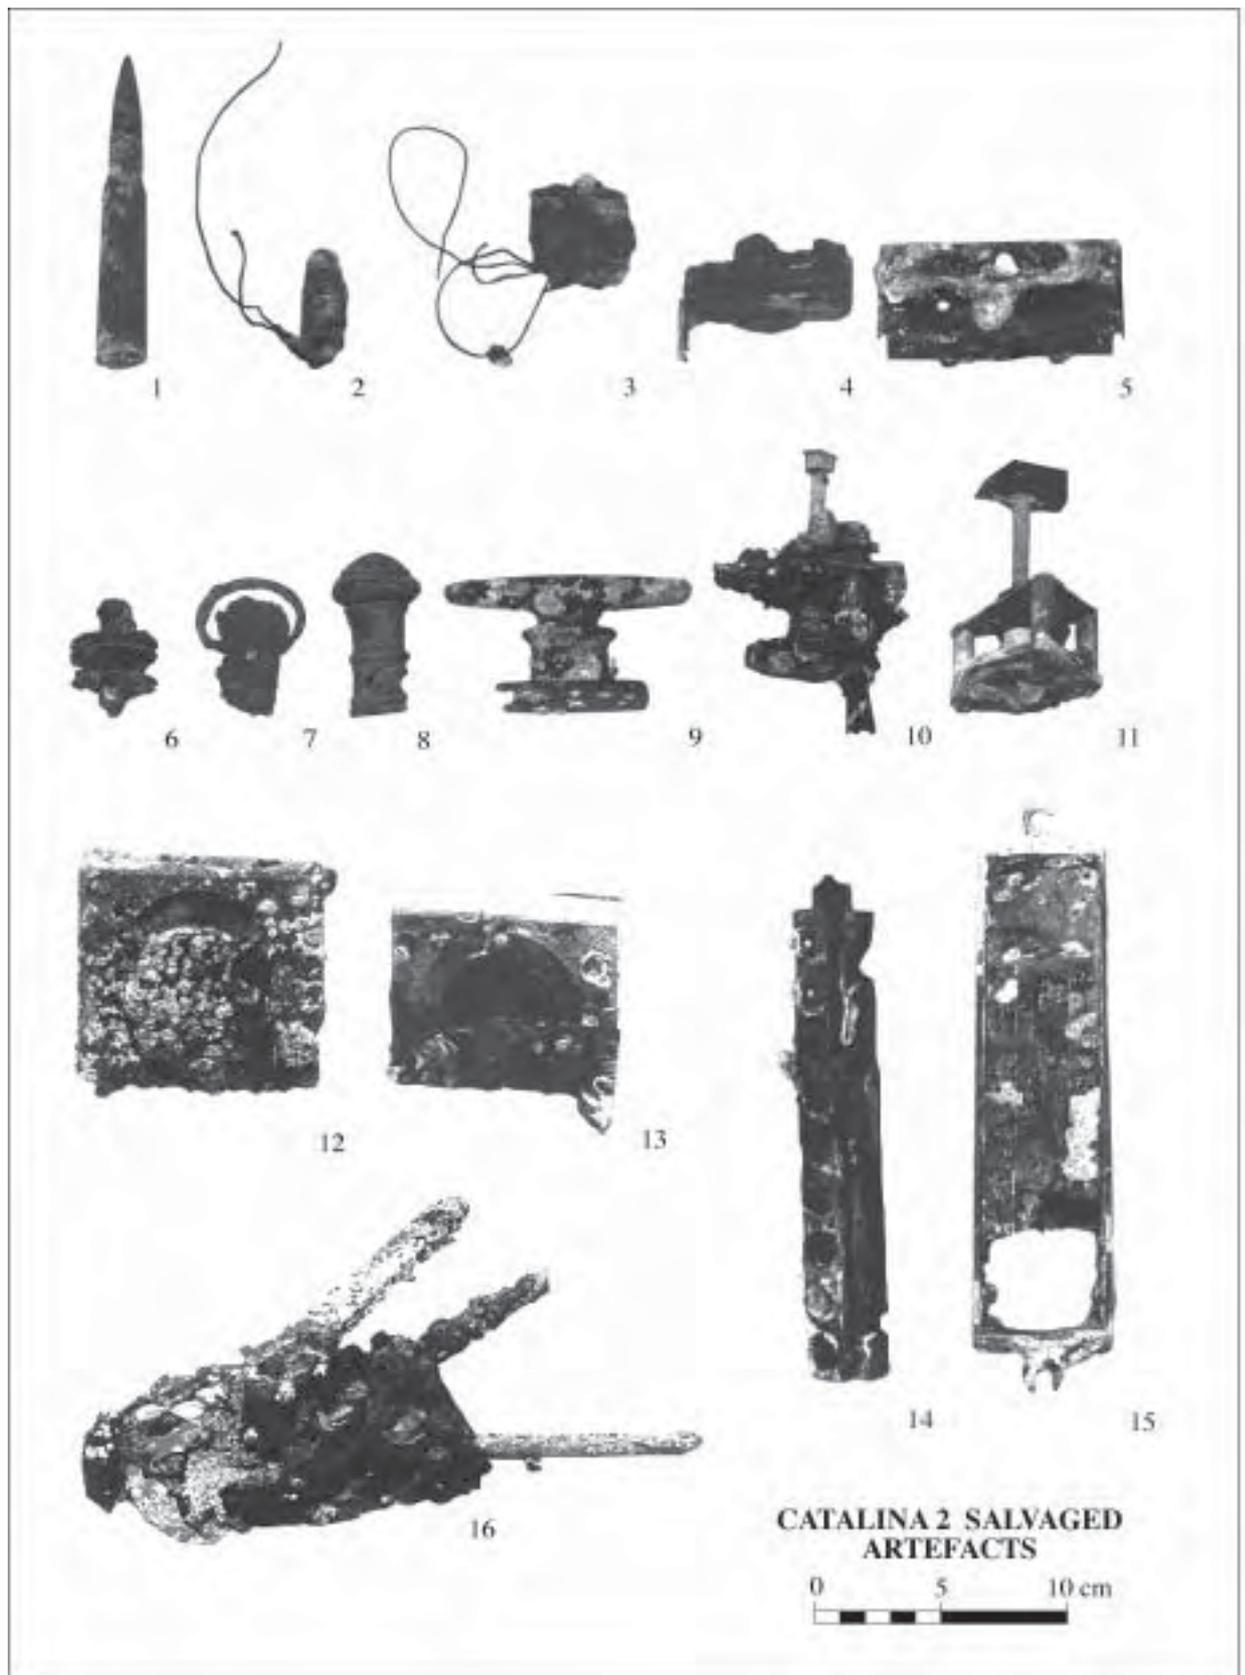
Figure 3. *Catalina 2* artefacts raised by the RANR in 1994. (1) 0.30' calibre bullet. (2) instrument panel light bulb. (3) instrument panel light bulb. (4-6) radio components. (7) handle. (8) bakerlight knob. (9) cleat. (10-11) radio tuners. (12-13) flight instrument gauges. (14) flight instrument panel light array. (15) scale. (16) throttle.

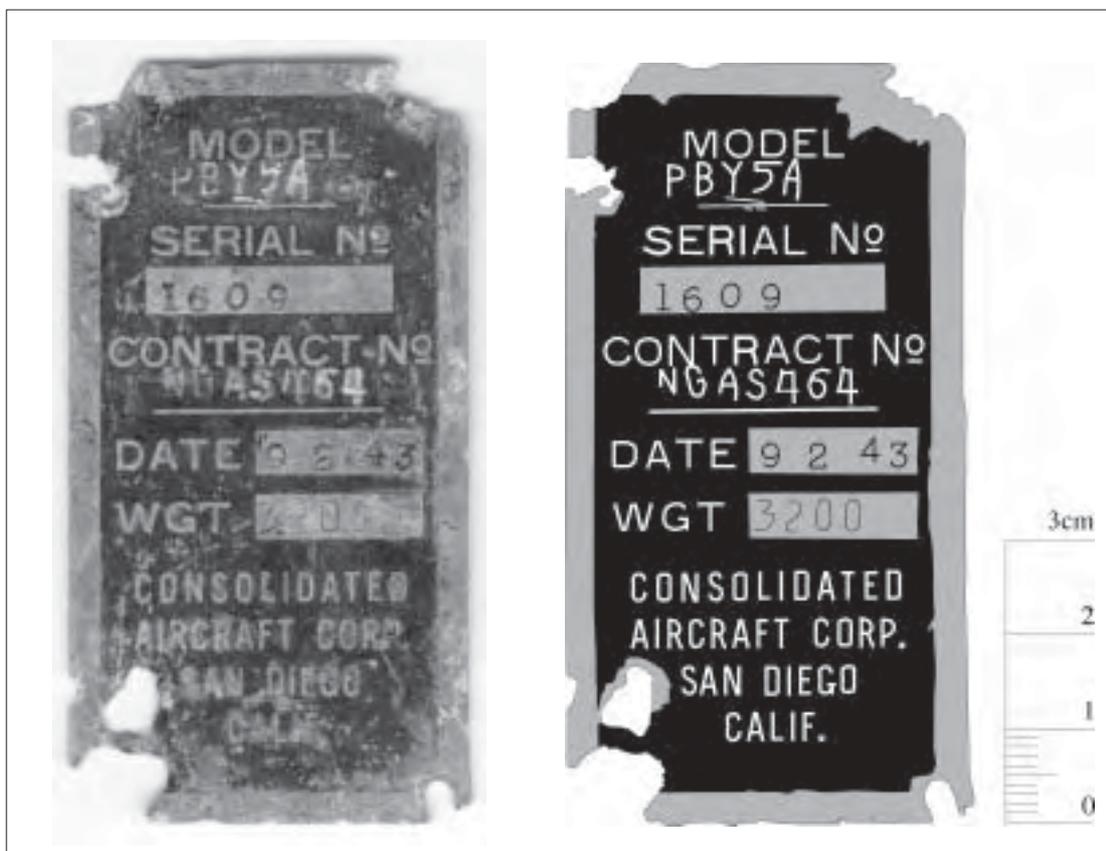
Figure 4. Contractor's plate photograph and line drawing.

The most diagnostic artefact seen so far from the Catalina 2 wreck site, however, is attributable to Rick Wiese's discovery of the contractor's plate (Fig. 4). This type of plate has not been found on any of the other located wrecks. It is, as result, a rare find. The plate recovered from Catalina 2 is for a PBY-5A model Catalina. Historical records show that the only Catalina of this model lost in East Arm was A24-69.

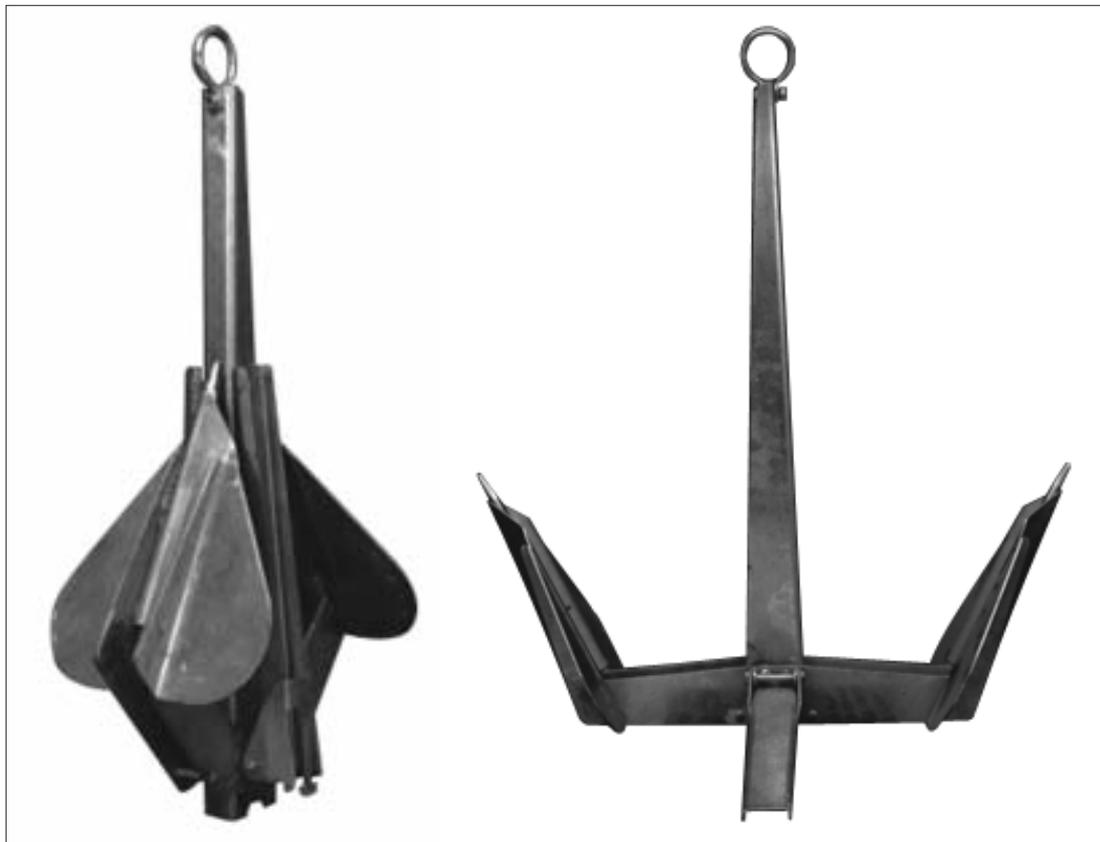
Photo 9. Standard size folding anchor from Catalina 4, folded (left) and extended (right) (Photo: Jung 1995).

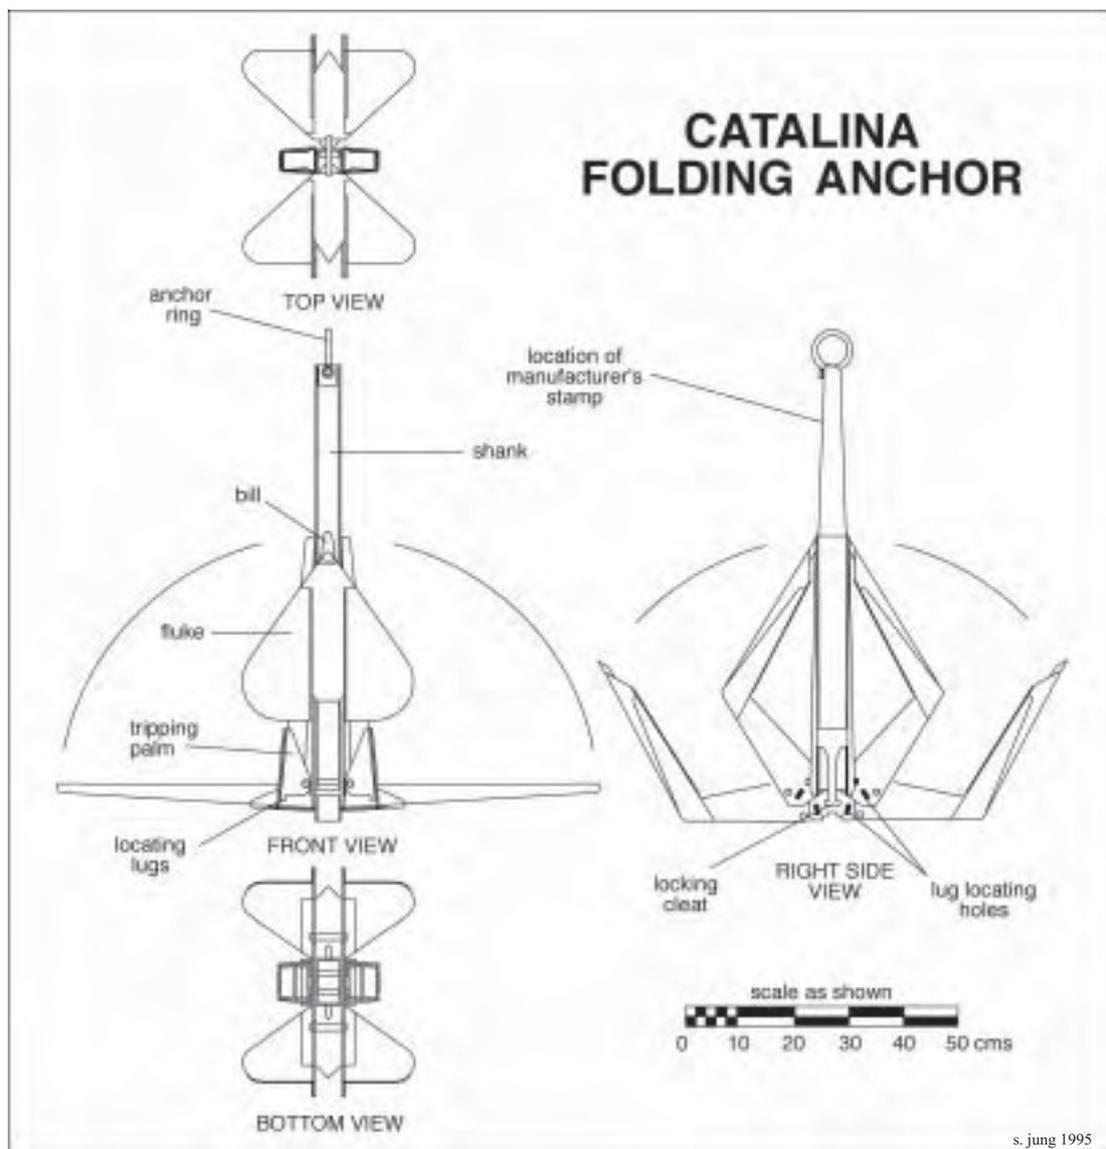
Figure 6. Line drawing of a standard type folding anchor recovered from Catalina 4.

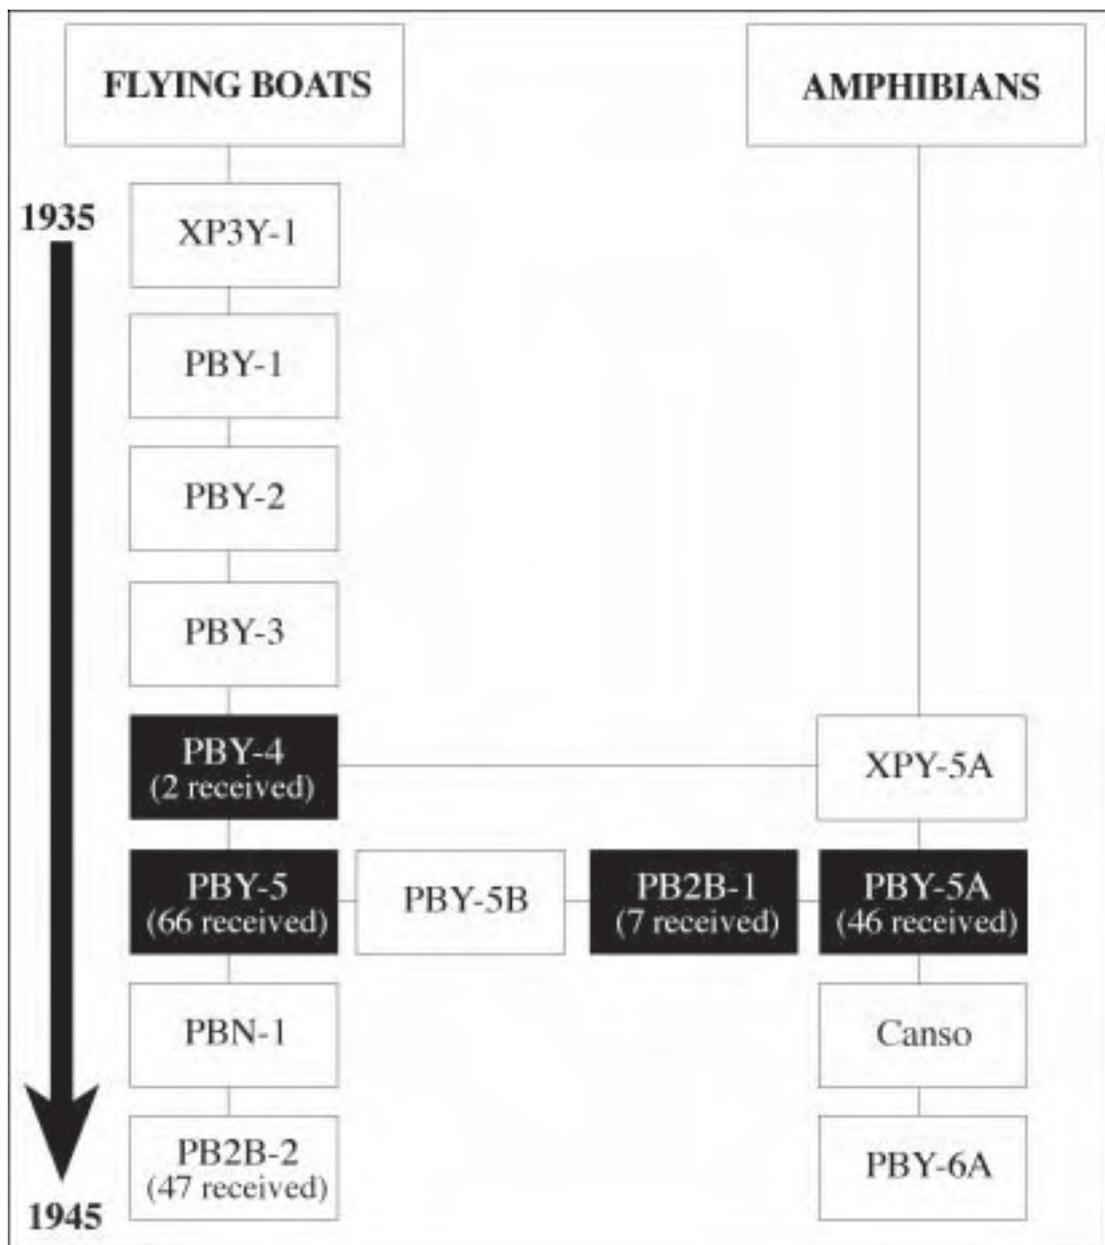
Figure 7. Evolutionary tree of the Catalina Flying Boat. Number received by the RAAF and examples lost in Darwin Harbour are in black boxes. Note: Type 28-5MNE same as PBY-5, USN only (After Vincent 1981:106).

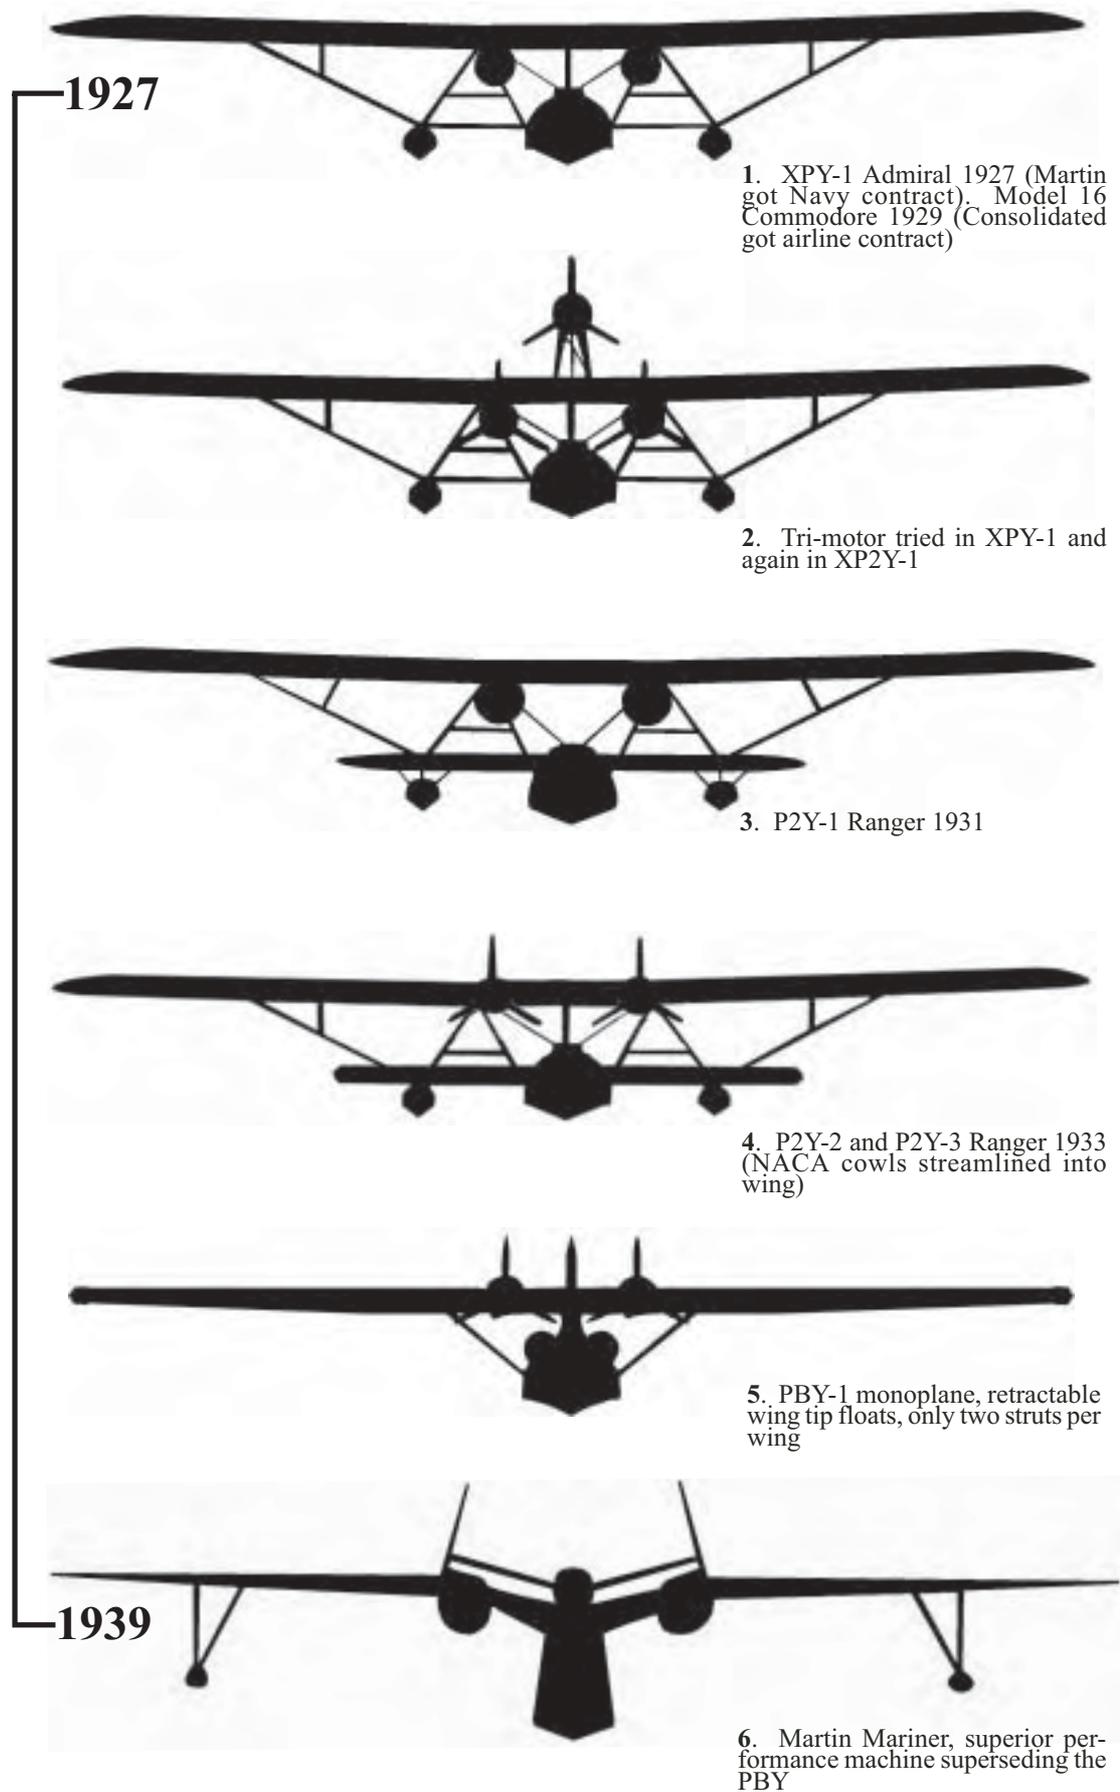
Figure 8. Flying boat lineage illustrating developments in wing and engine layouts over time. Not to scale (Wagner 1976:162; Freeman 1995:145).

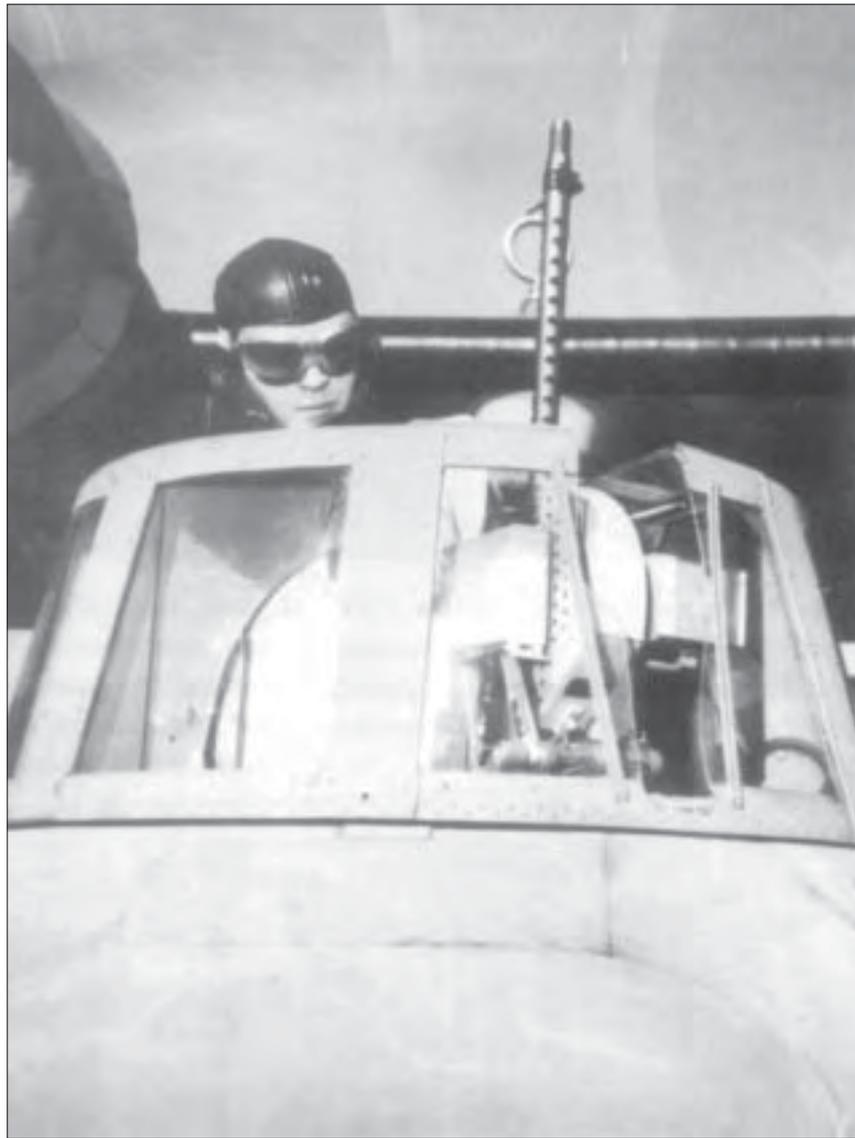
Photo 13. The standard type gun turret on pre-PBY-5A Catalina types with the single .30 in. calibre machine gun (Kinzey 2000:56).

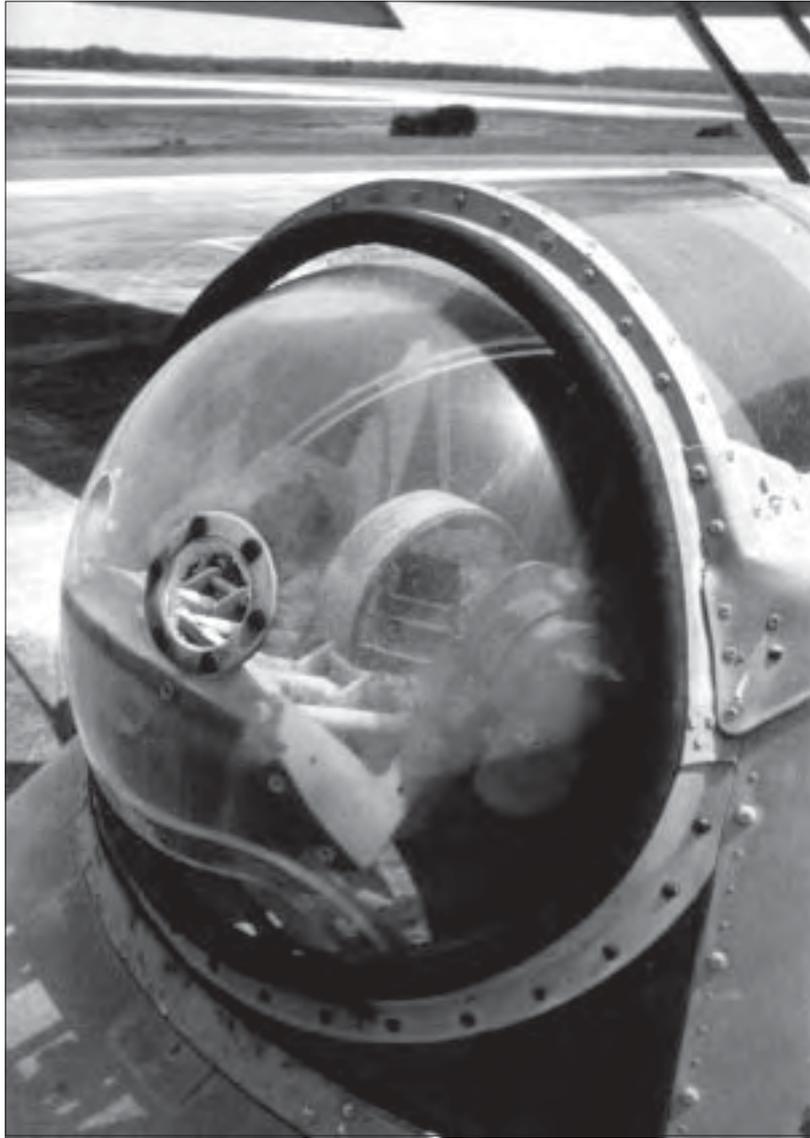
Photo 14. Bug eye turret on the PBY-5A and later Catalina types with twin .30 in. calibre machine guns (Scarborough 1995:16).

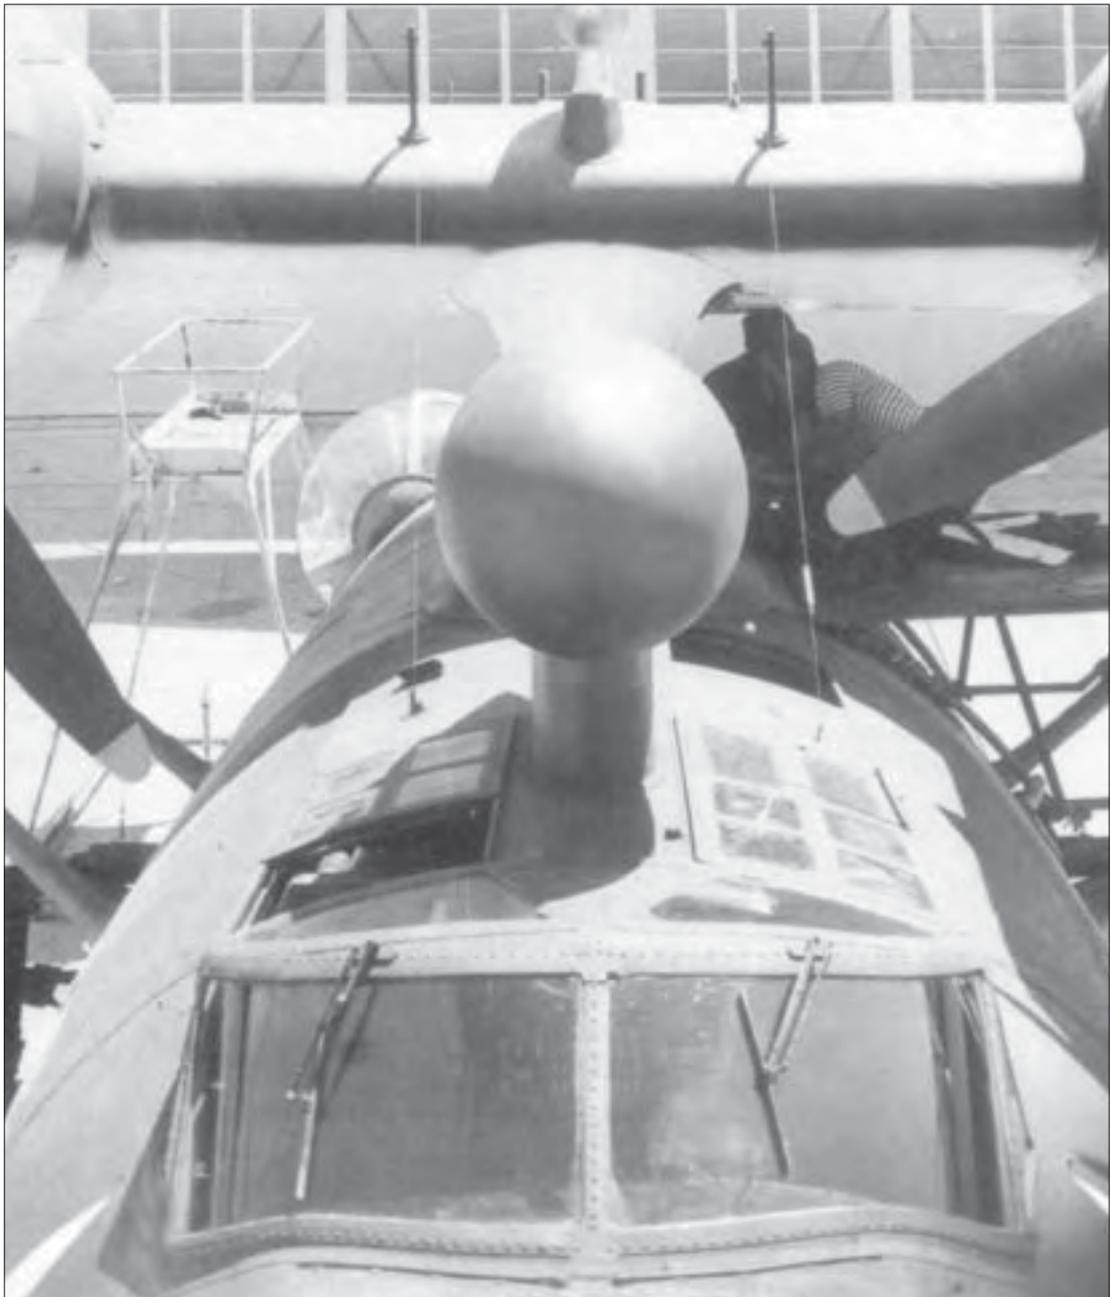
Photo 15. The radome mounted above the cockpit of a PBY-6A, similar to the one mounted on A24-206 (Kinzey 2000:73).

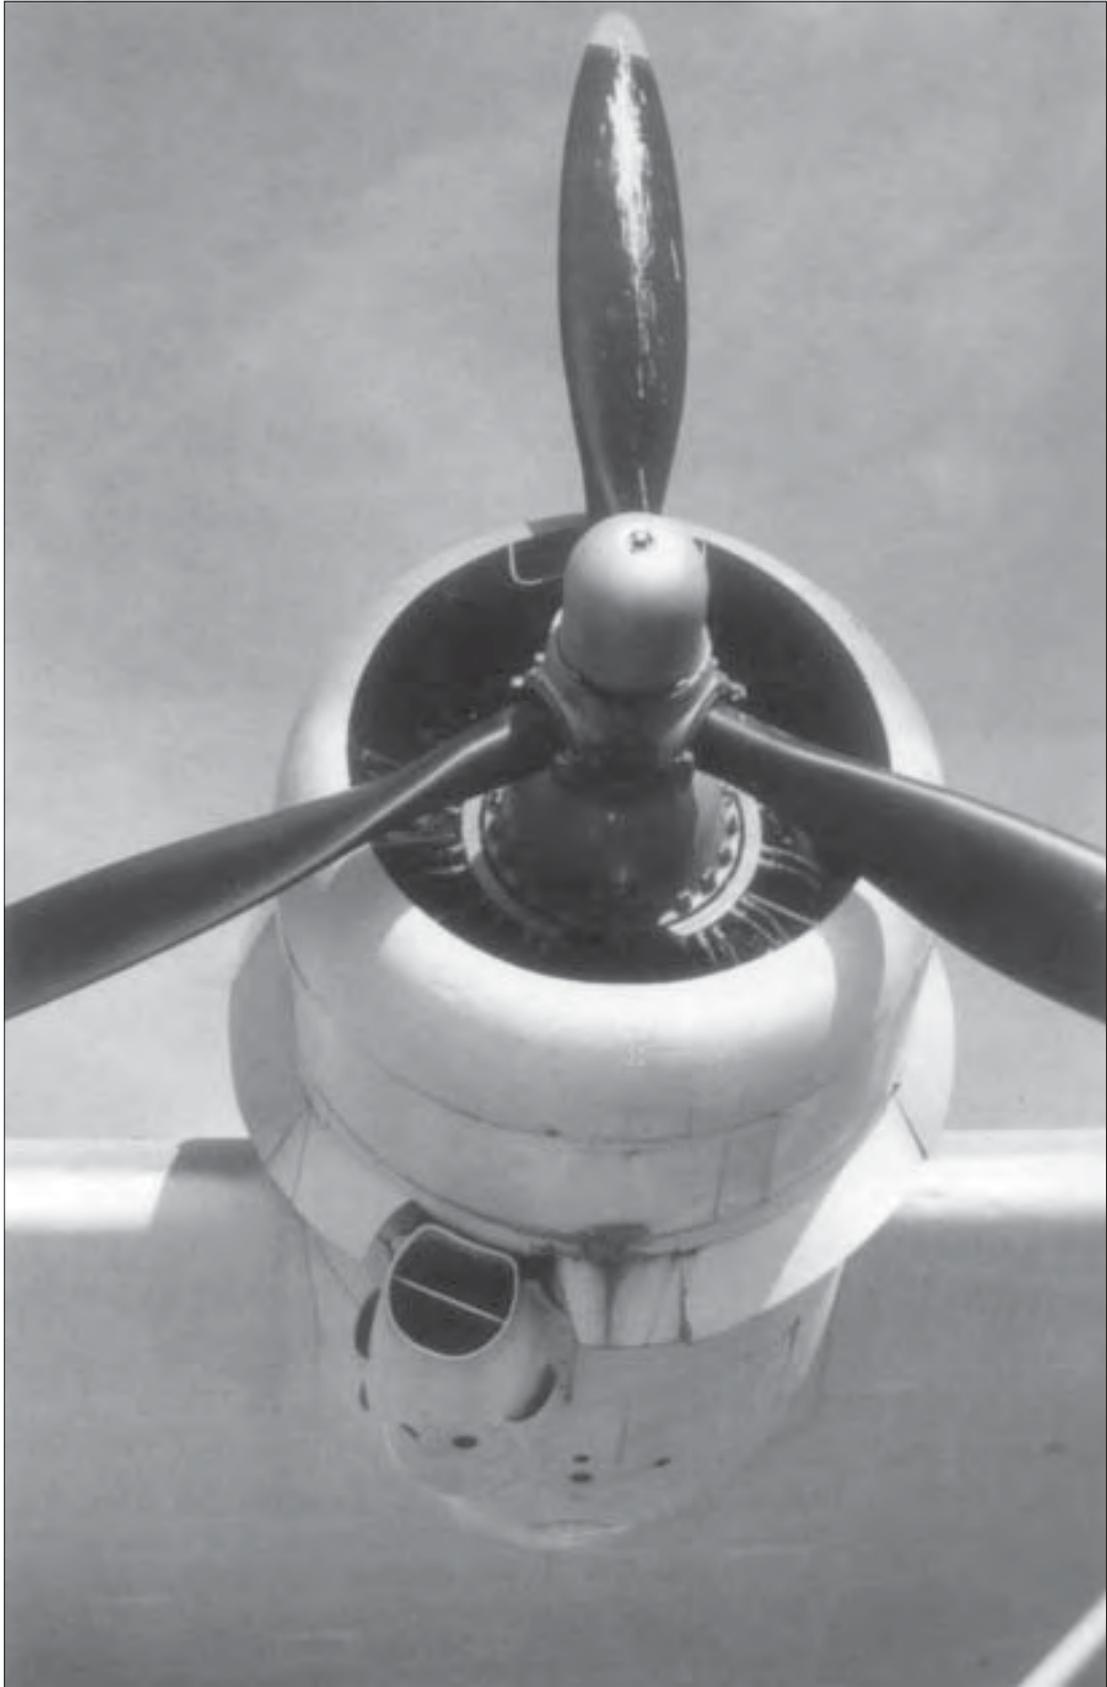
Photo 18. The Pratt & Whitney R-1830-92 engine. Note the oil cooler below the engine to left on the nacelle and the air intake inside the cowling (Kinzey2000:48).

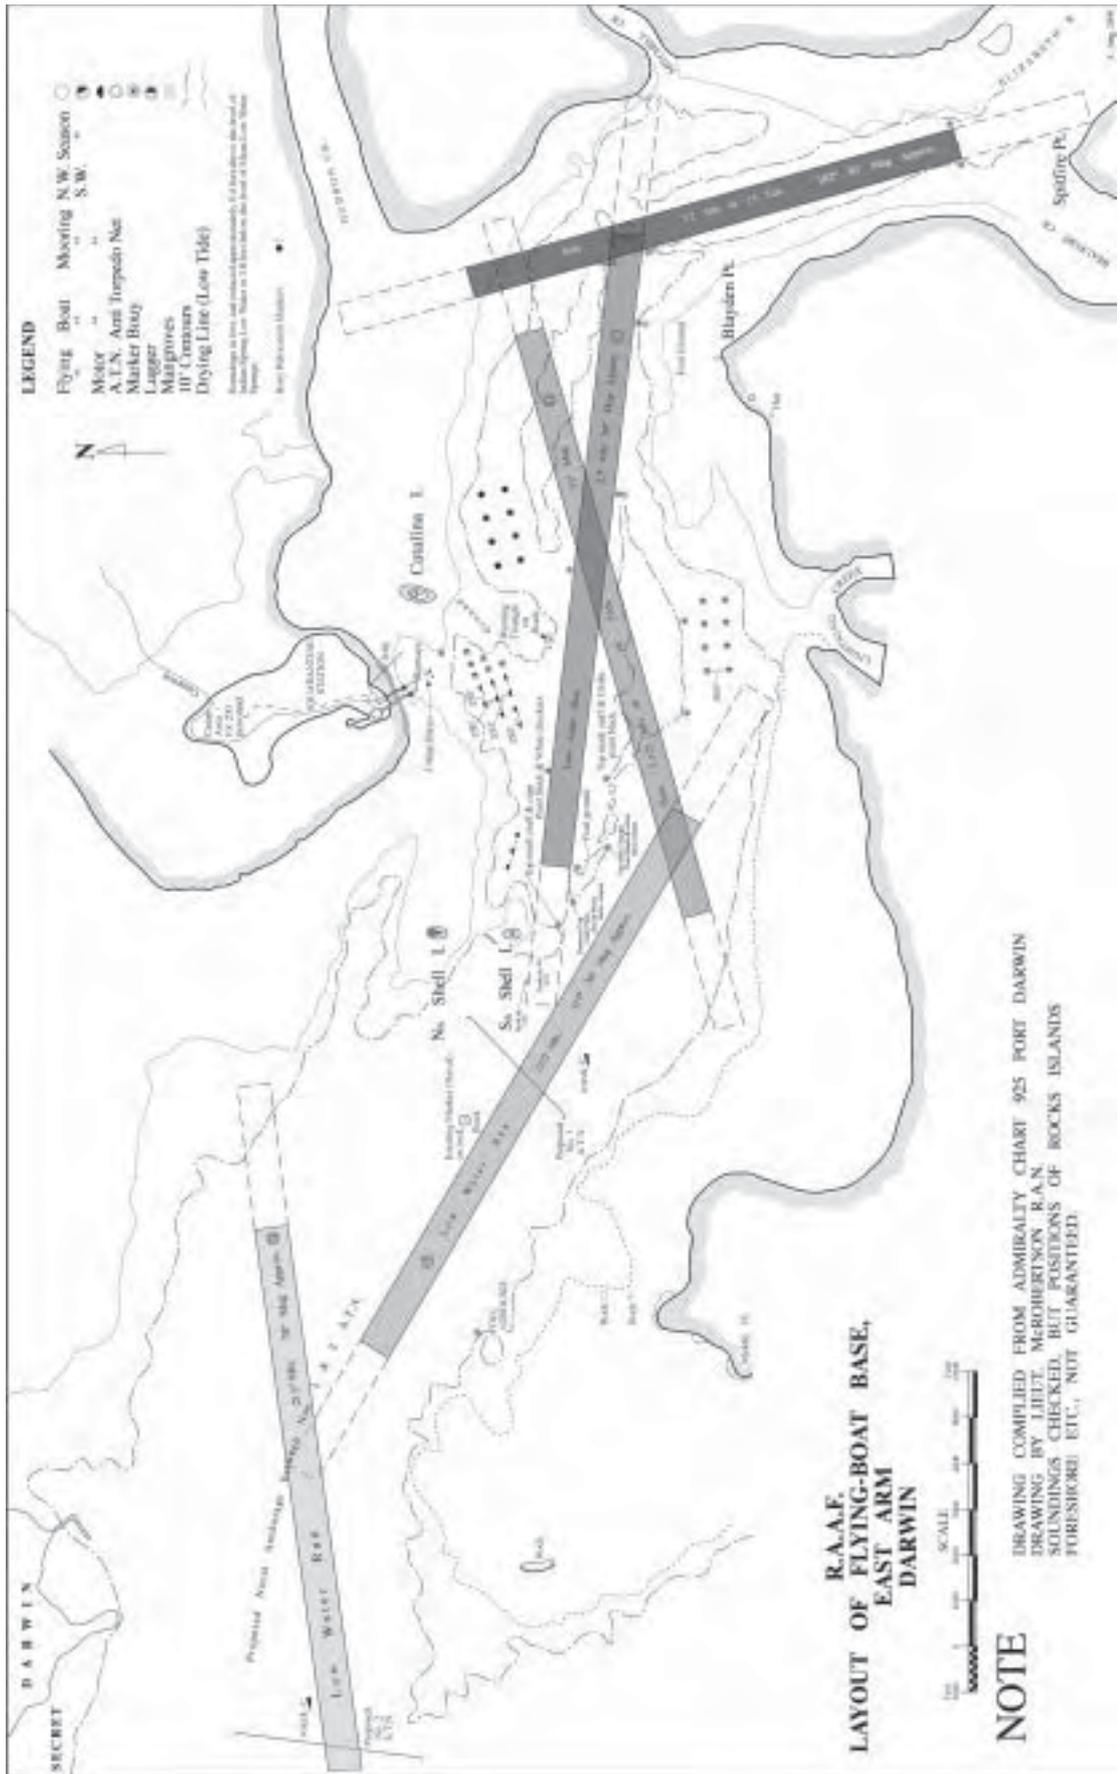
Figure 17. RAAF layout of Flying Boat base, East Arm, Darwin (Series: A705/7. Item: 171/6/218. National Archives of Australia).

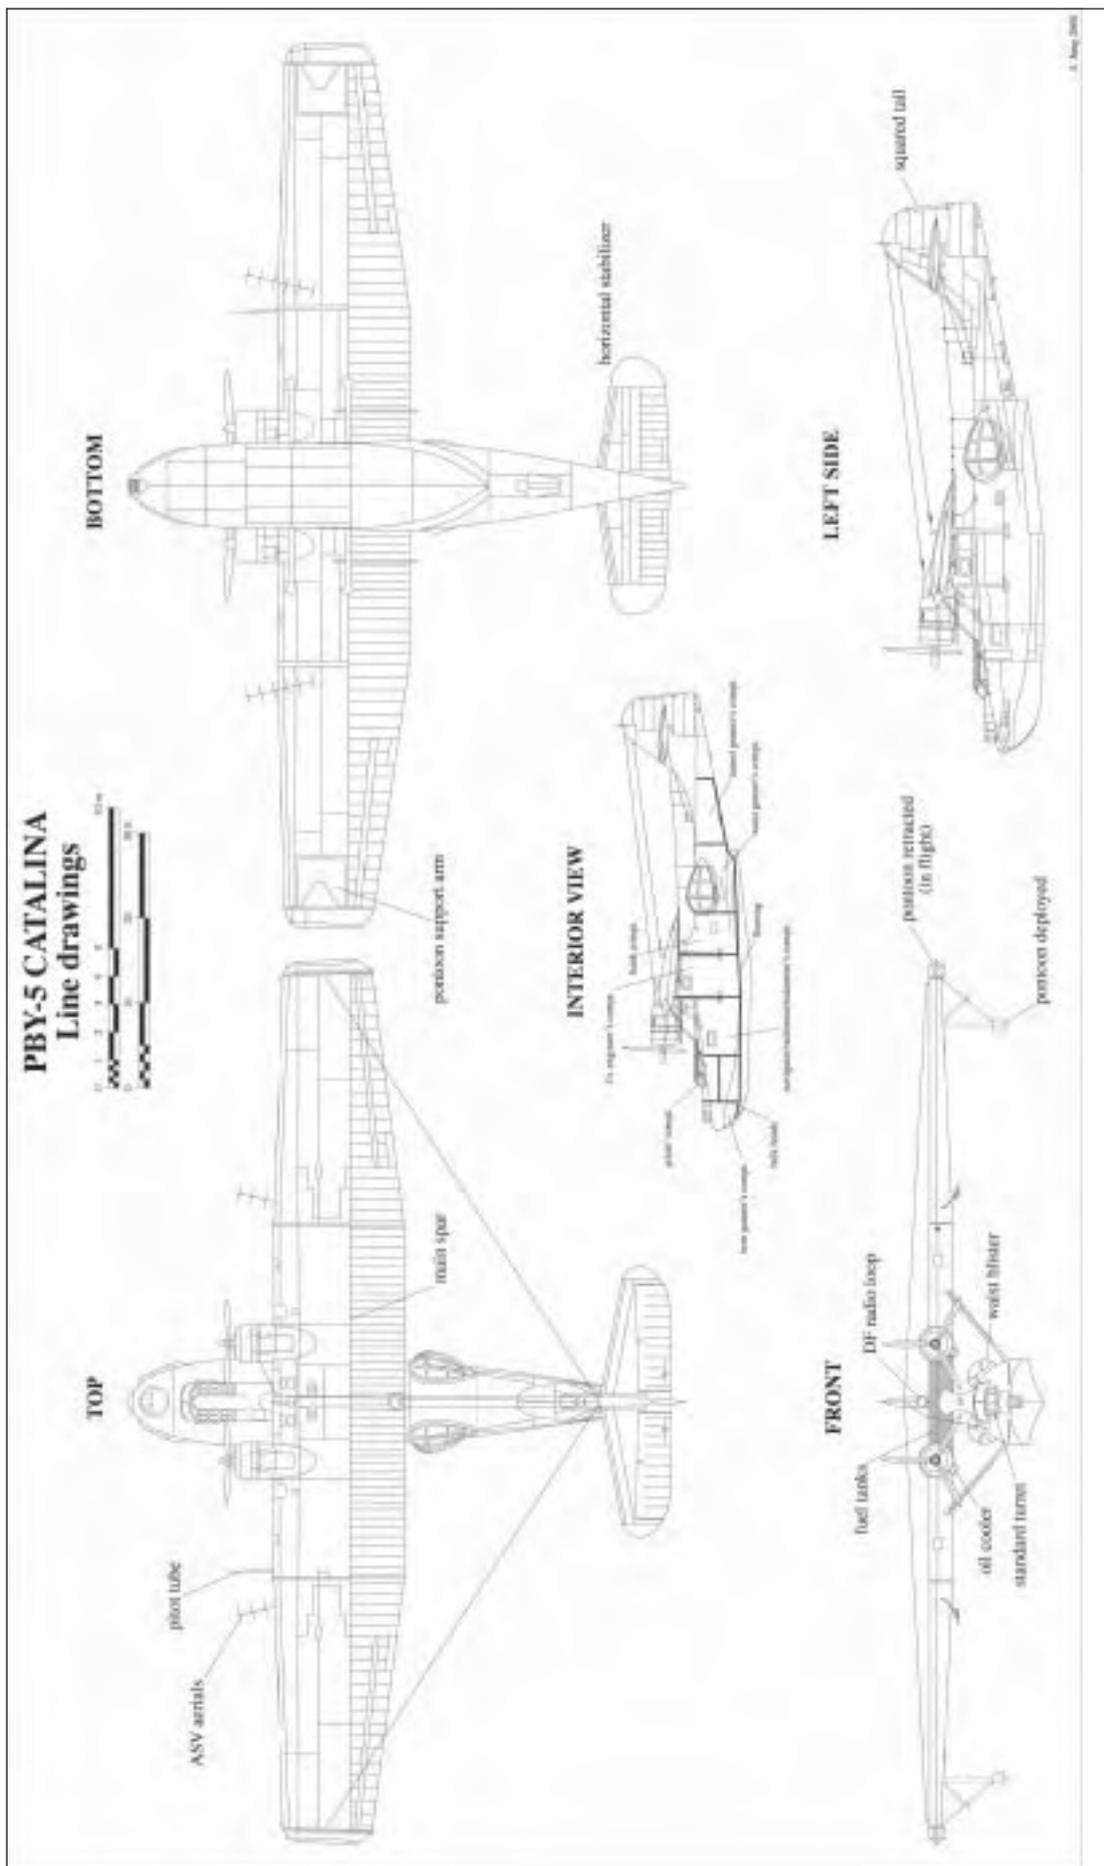
Figure 19. PBY-5 Catalina line drawings (After Knott 1981; Scarborough 1985).

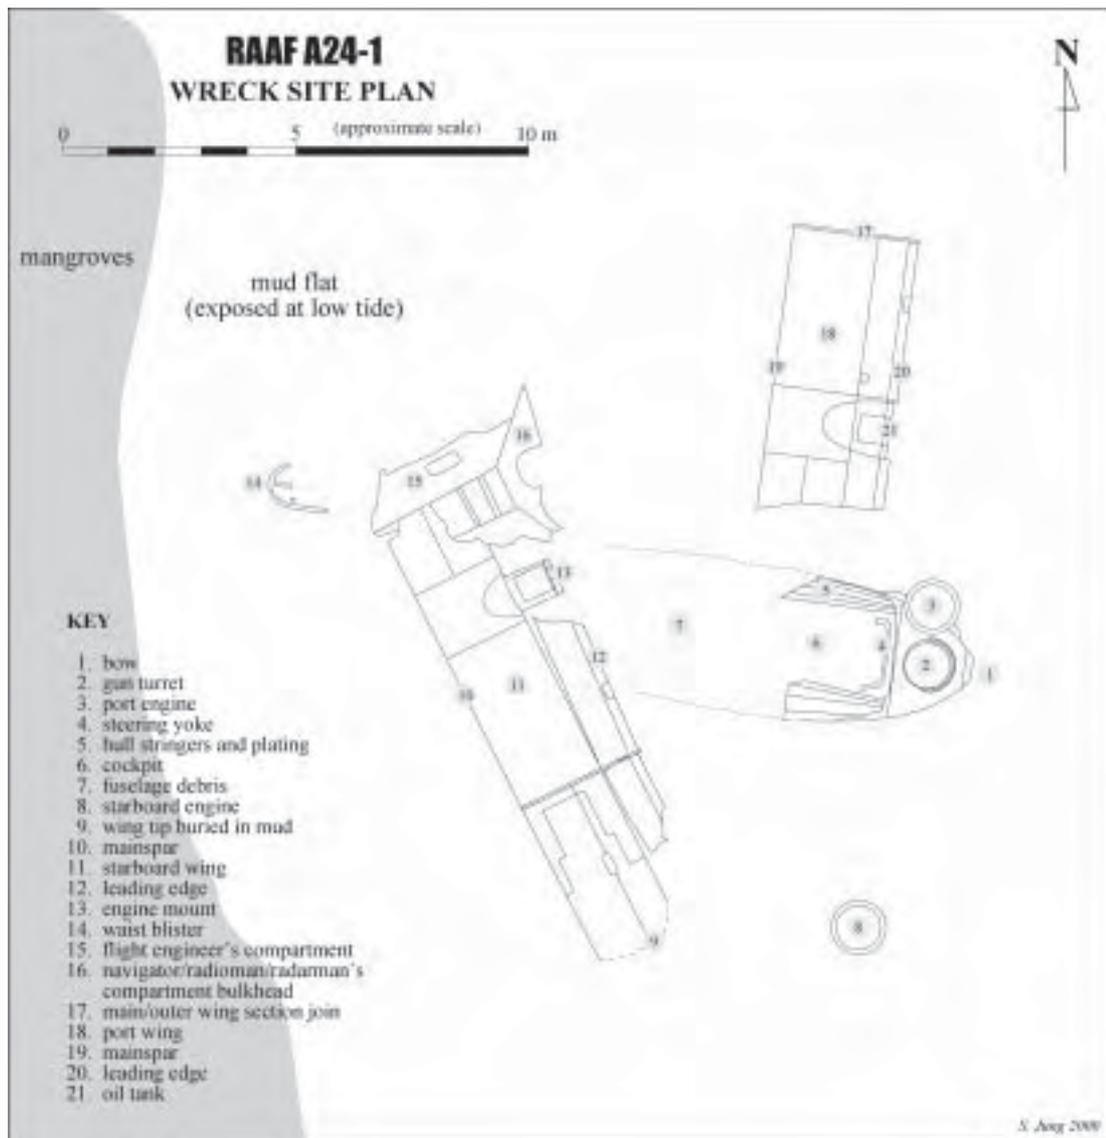
Figure 20. A24-1 wreck site plan.

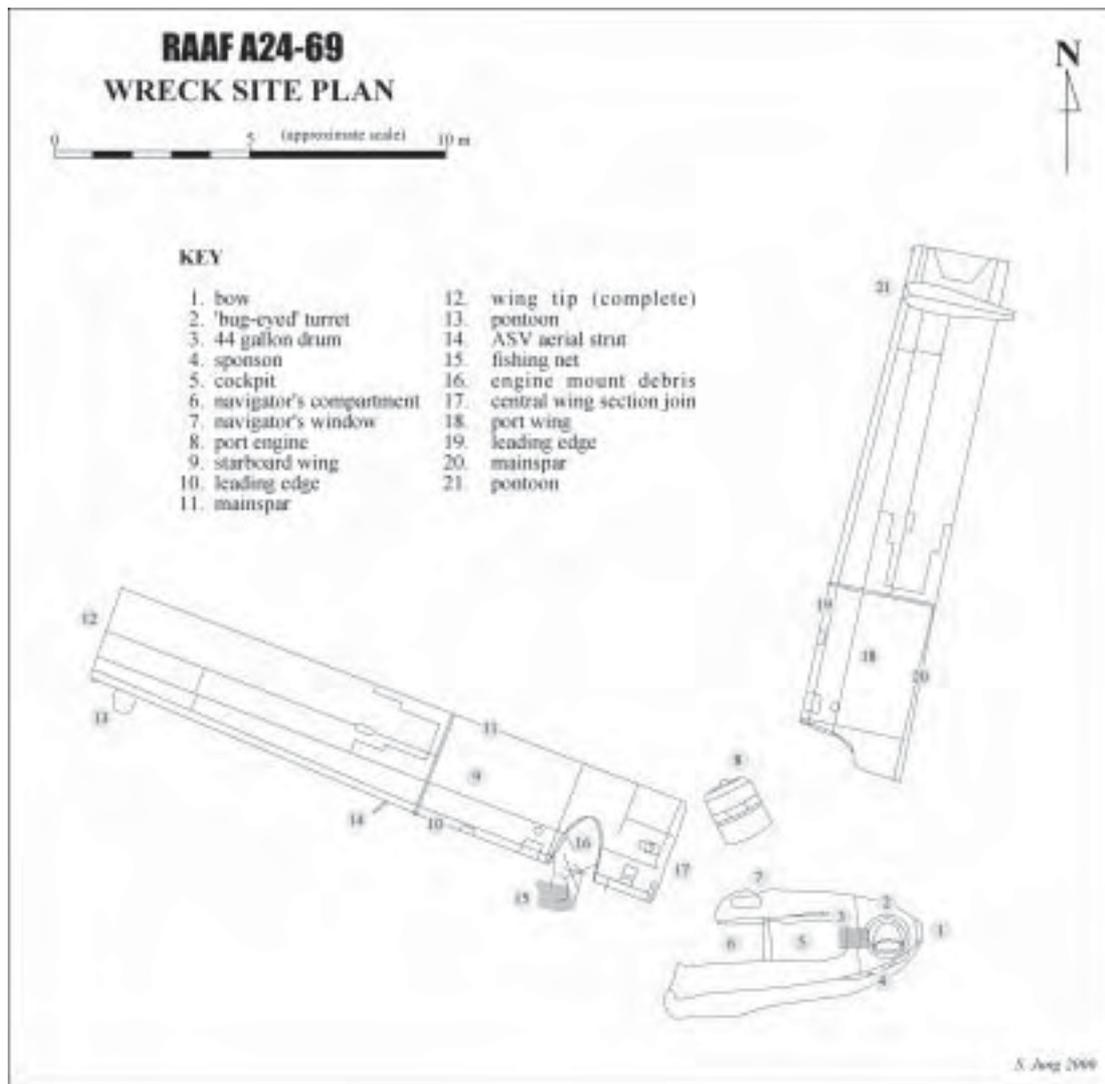
Figure 21. *Catalina 2 wreck site plan.*

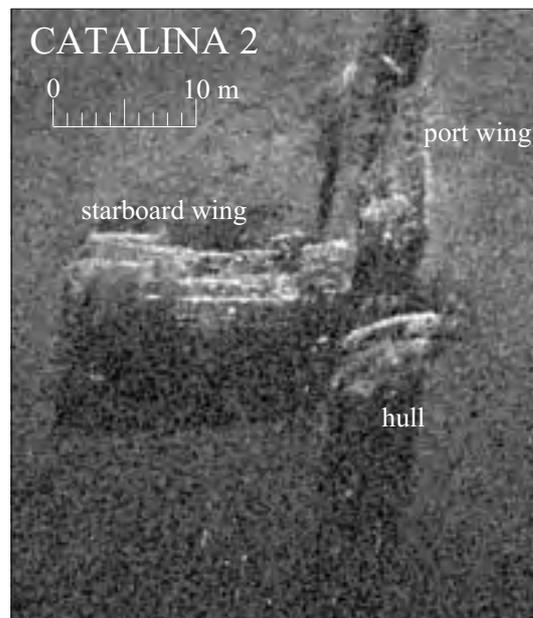
Figure 22. Side scan sonar image of the Catalina 2 (WA Maritime Museum 1998).

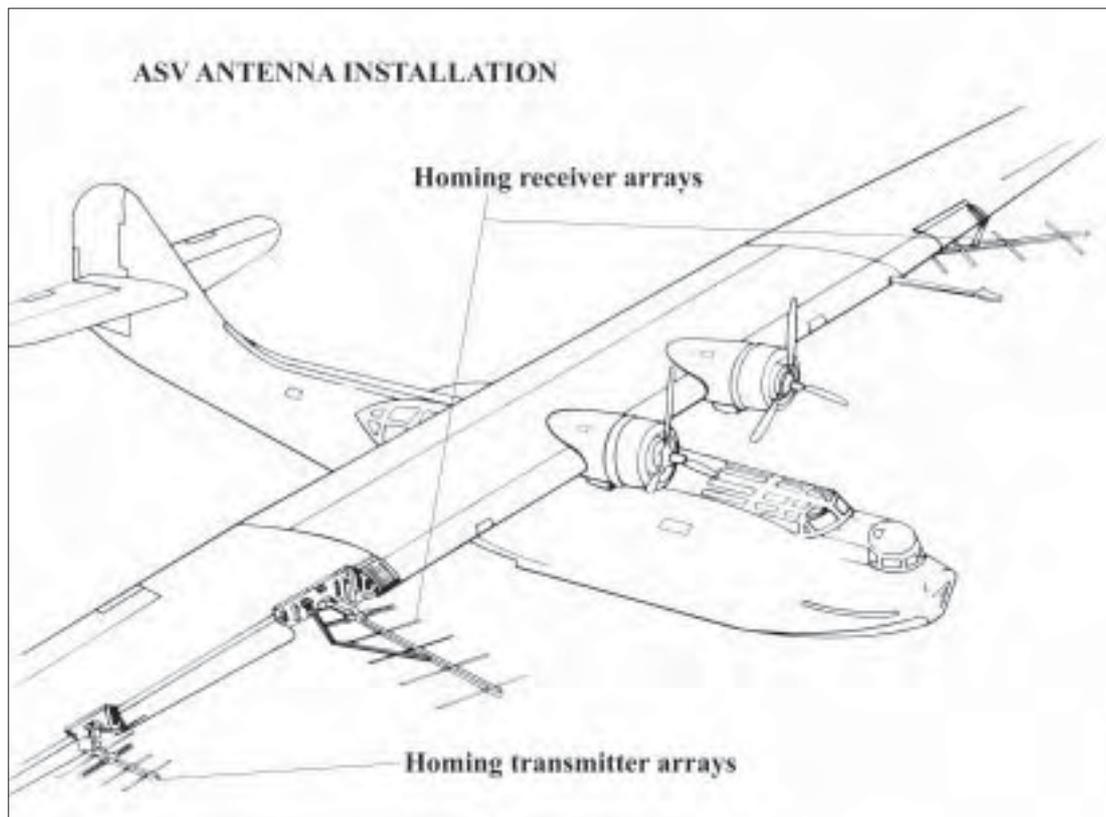
Figure 23. *ASV antenna installation. The starboard wing receiving array is visible on the Catalina 2 wreck site (Scarborough 1983:32).*
