WINGS BENEATH THE SEA:
the aviation archaeology of Catalina flying boats in Darwin Harbour,
Northern Territory

Thesis submitted for the degree of Master of Arts in the
Faculty of Law, Business and Arts
Northern Territory University
2001

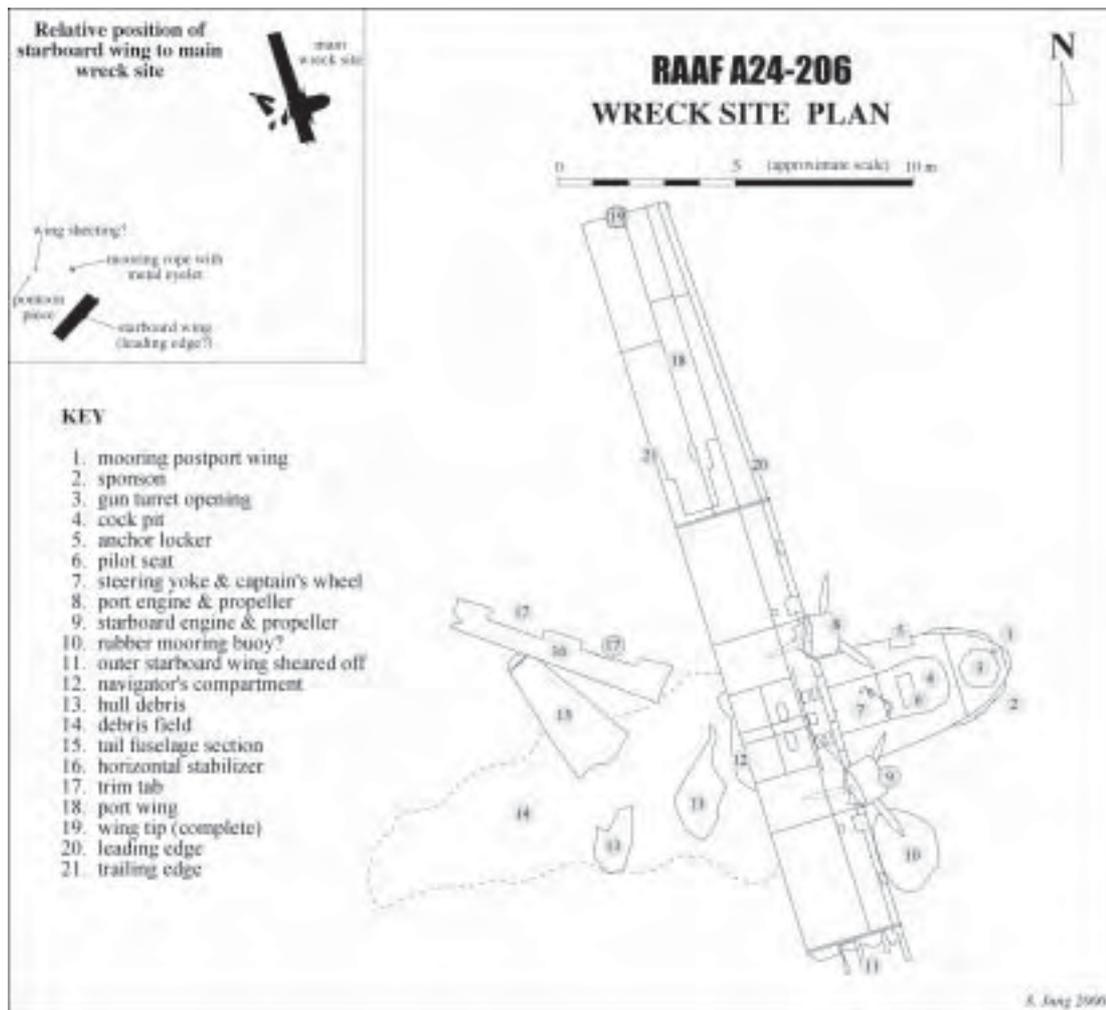
Figure 24. Catalina 3 wreck site plan. Note the separation of the starboard outer wing tip that lies approximately forty to sixty metres away from the main wreck site.

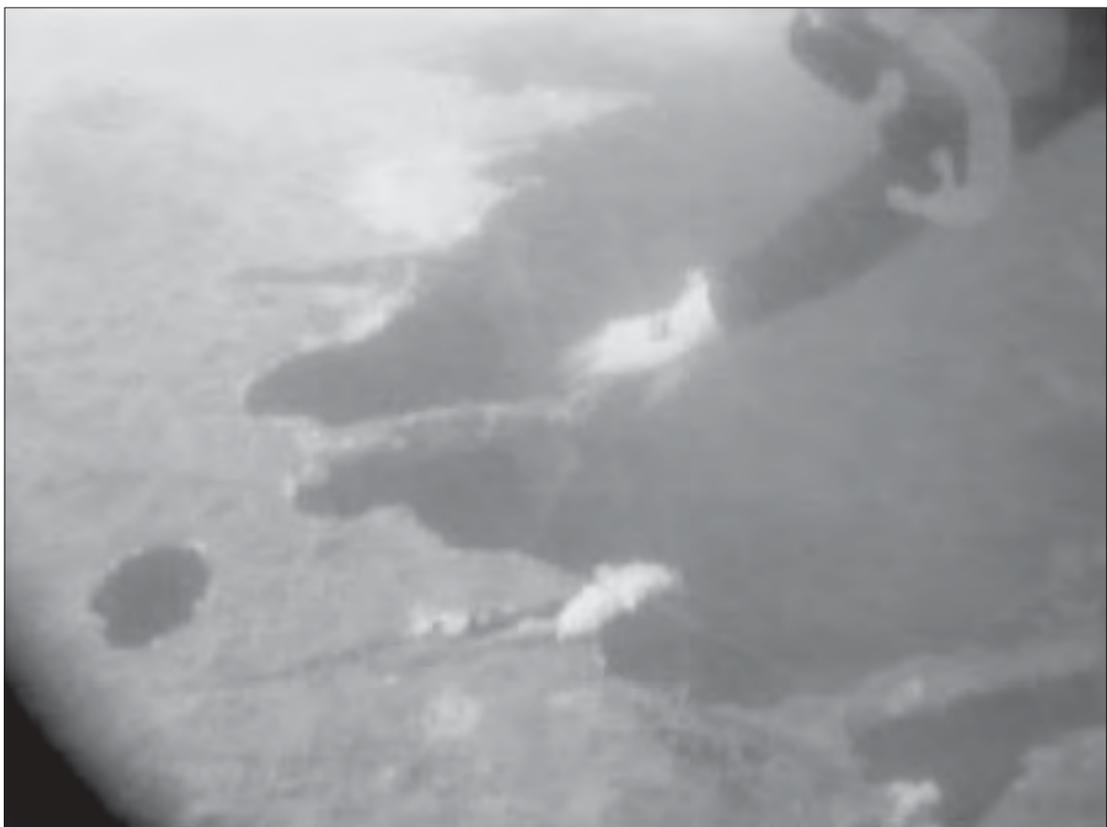
Photo 67. Bob Ramsey inspects the hole in the port wing on Catalina 4 (Photo: Coroneos 1995).

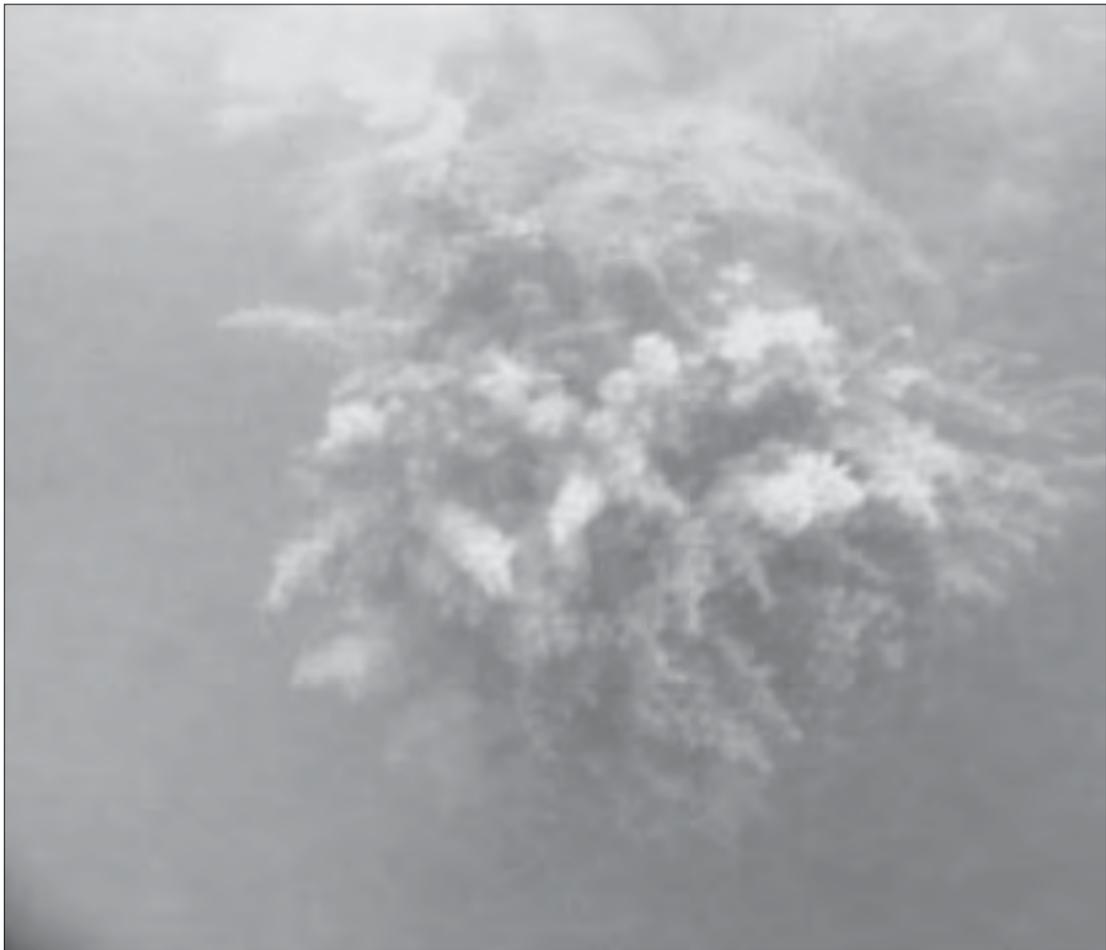
Photo 68. Spinner hub on Catalina 4 starboard engine propeller (Photo: Coroneos 1995).

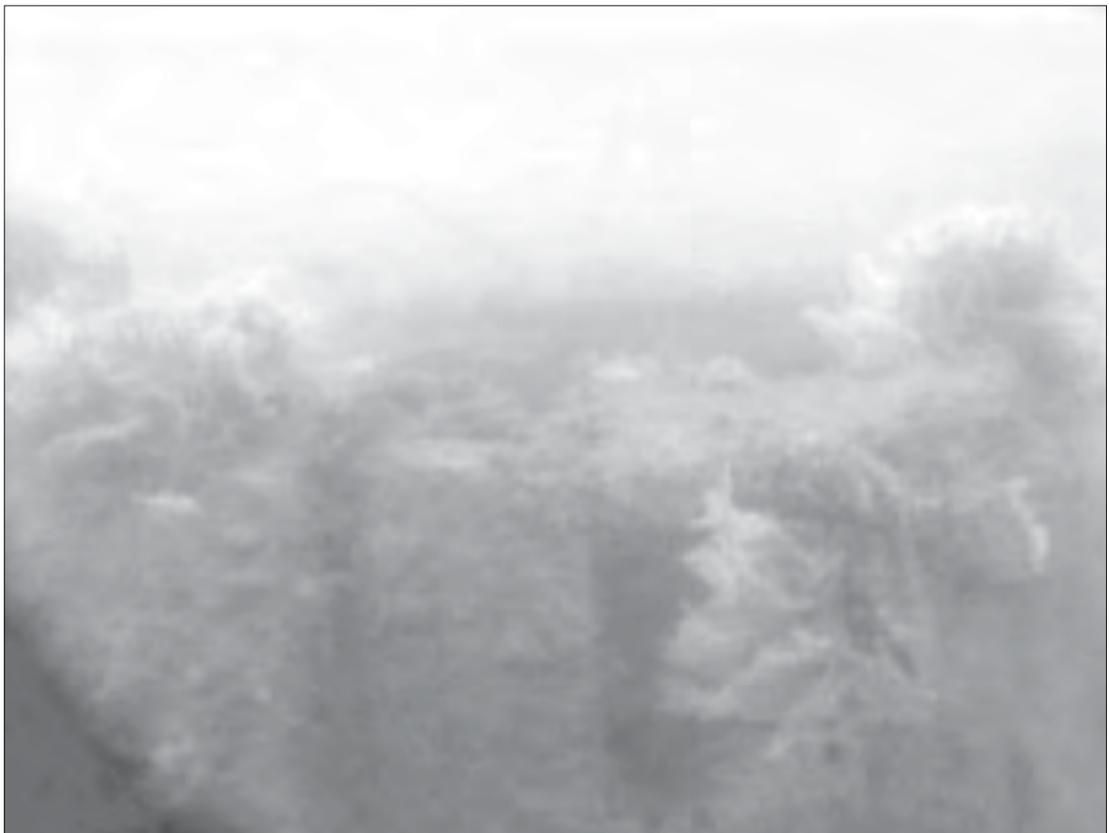
Photo 70. Starboard bow view of the standard turret on the Catalina 4 wreck site (Photo: Coroneos 1995).

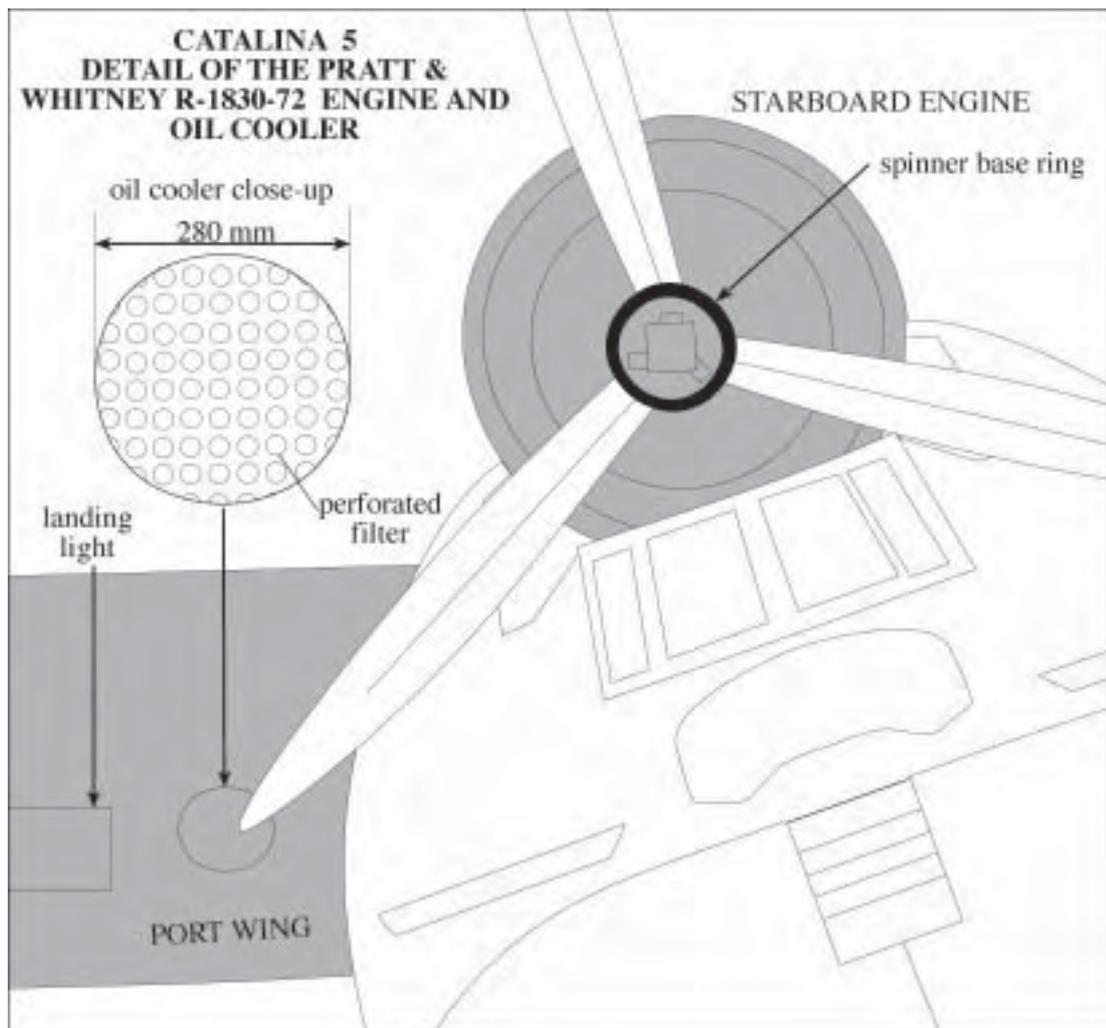
Figure 27. Catalina 5 showing details of the Pratt and Whitney R-1830-72 engine on top of the navigator's compartment (see also Fig. 34).

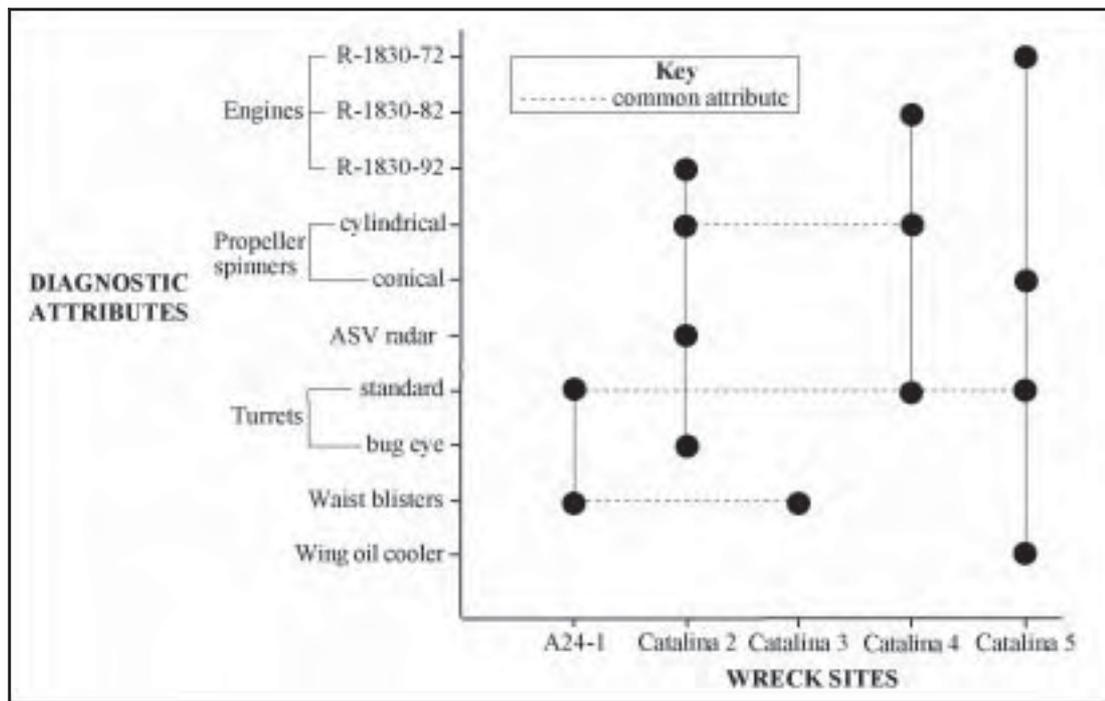
Figure 28. Comparison between wreck sites and diagnostic attributes.

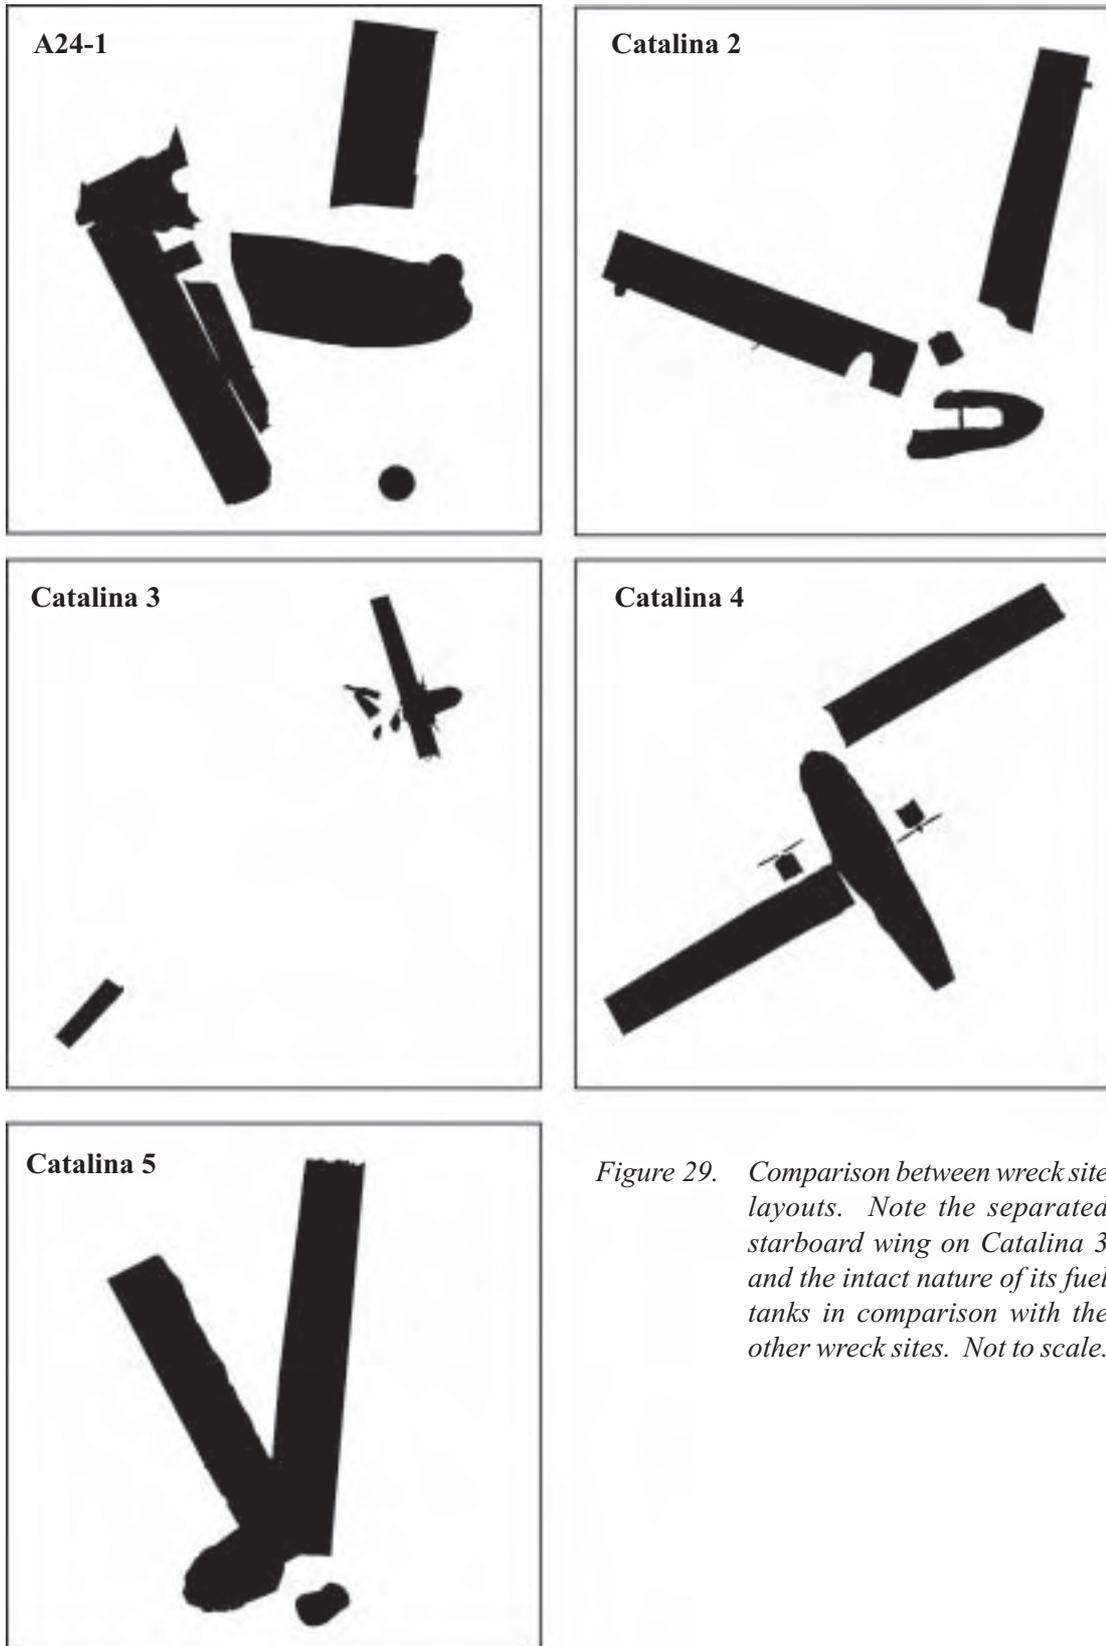
Figure 29. Comparison between wreck site layouts. Note the separated starboard wing on Catalina 3 and the intact nature of its fuel tanks in comparison with the other wreck sites. Not to scale.

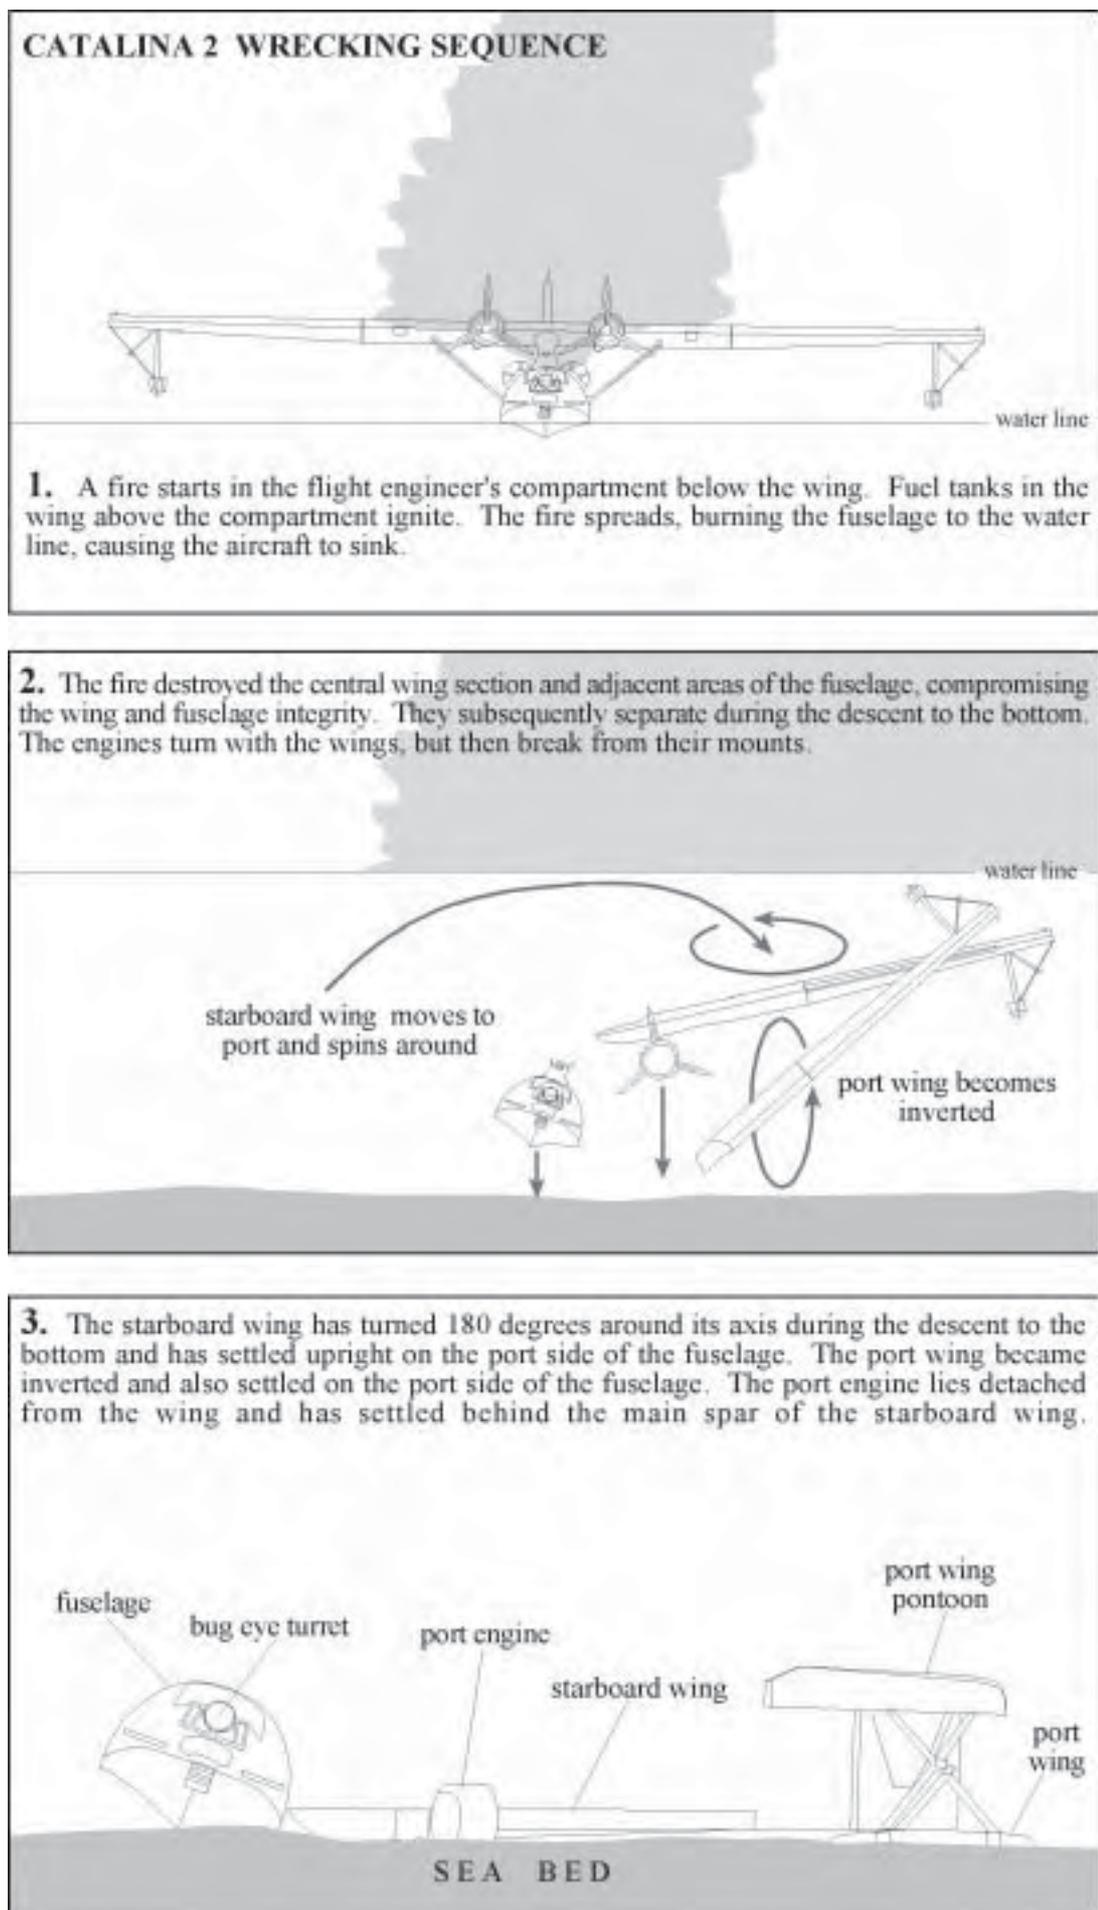
Figure 30. Wrecking sequence of Catalina 2.

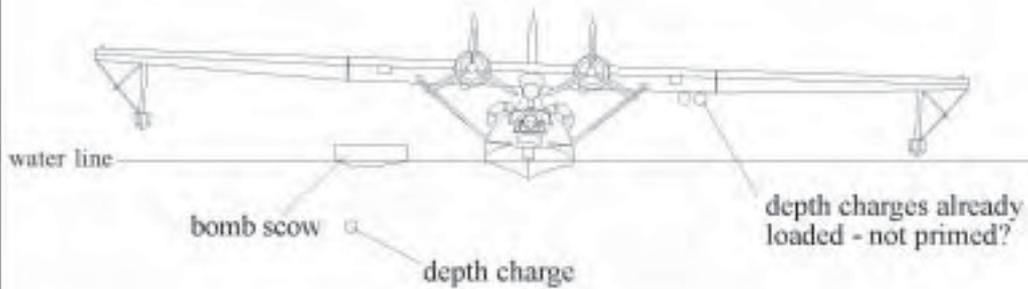
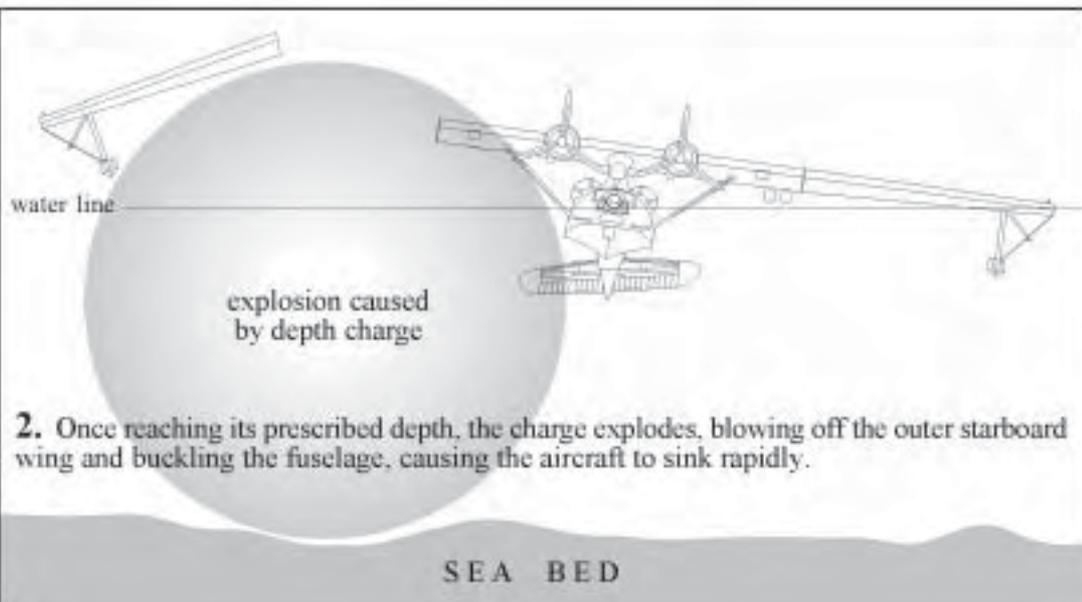
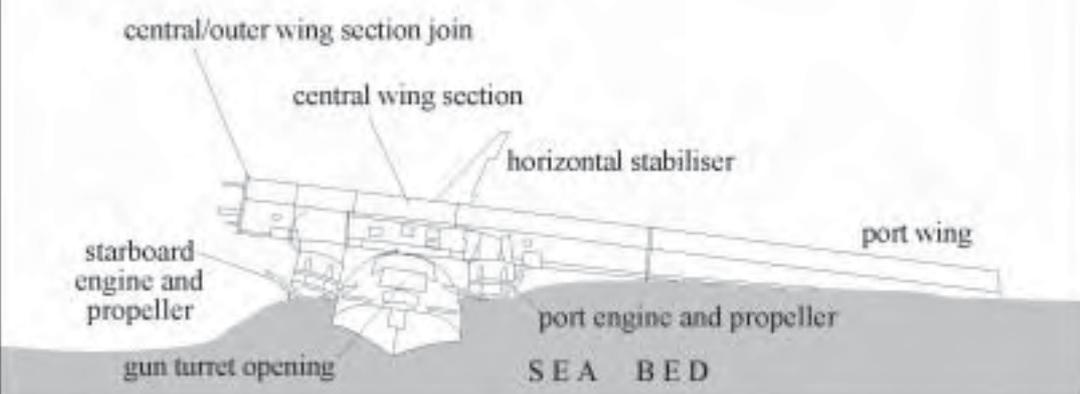
2. Once reaching its prescribed depth, the charge explodes, blowing off the outer starboard wing and buckling the fuselage, causing the aircraft to sink rapidly.

Figure 31. Wrecking sequence of Catalina 3.

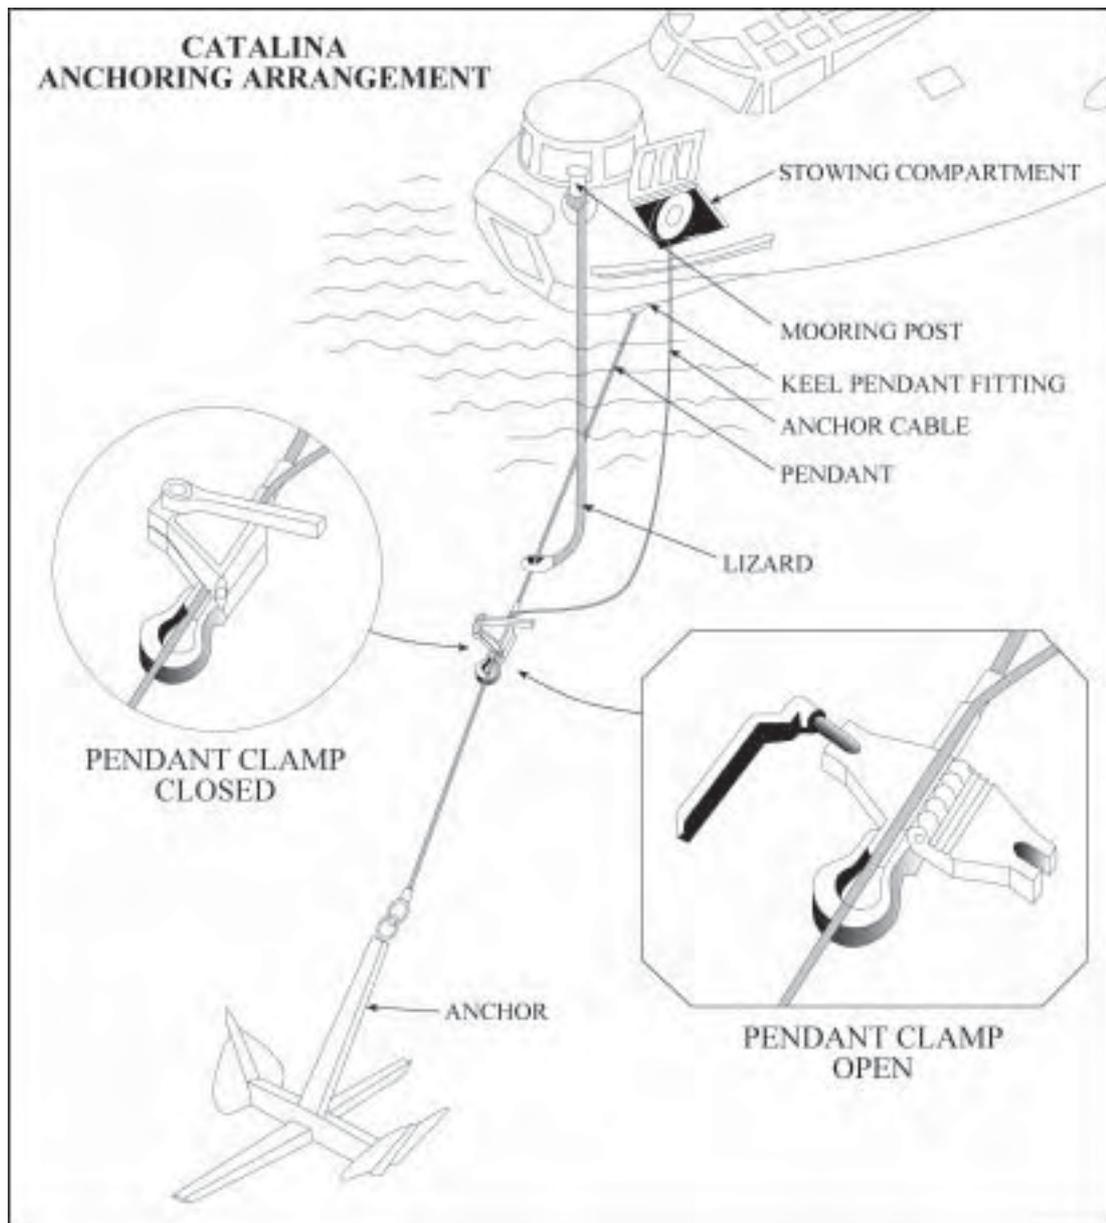
Figure 32. Catalina mooring arrangement (Scarborough 1995:10).

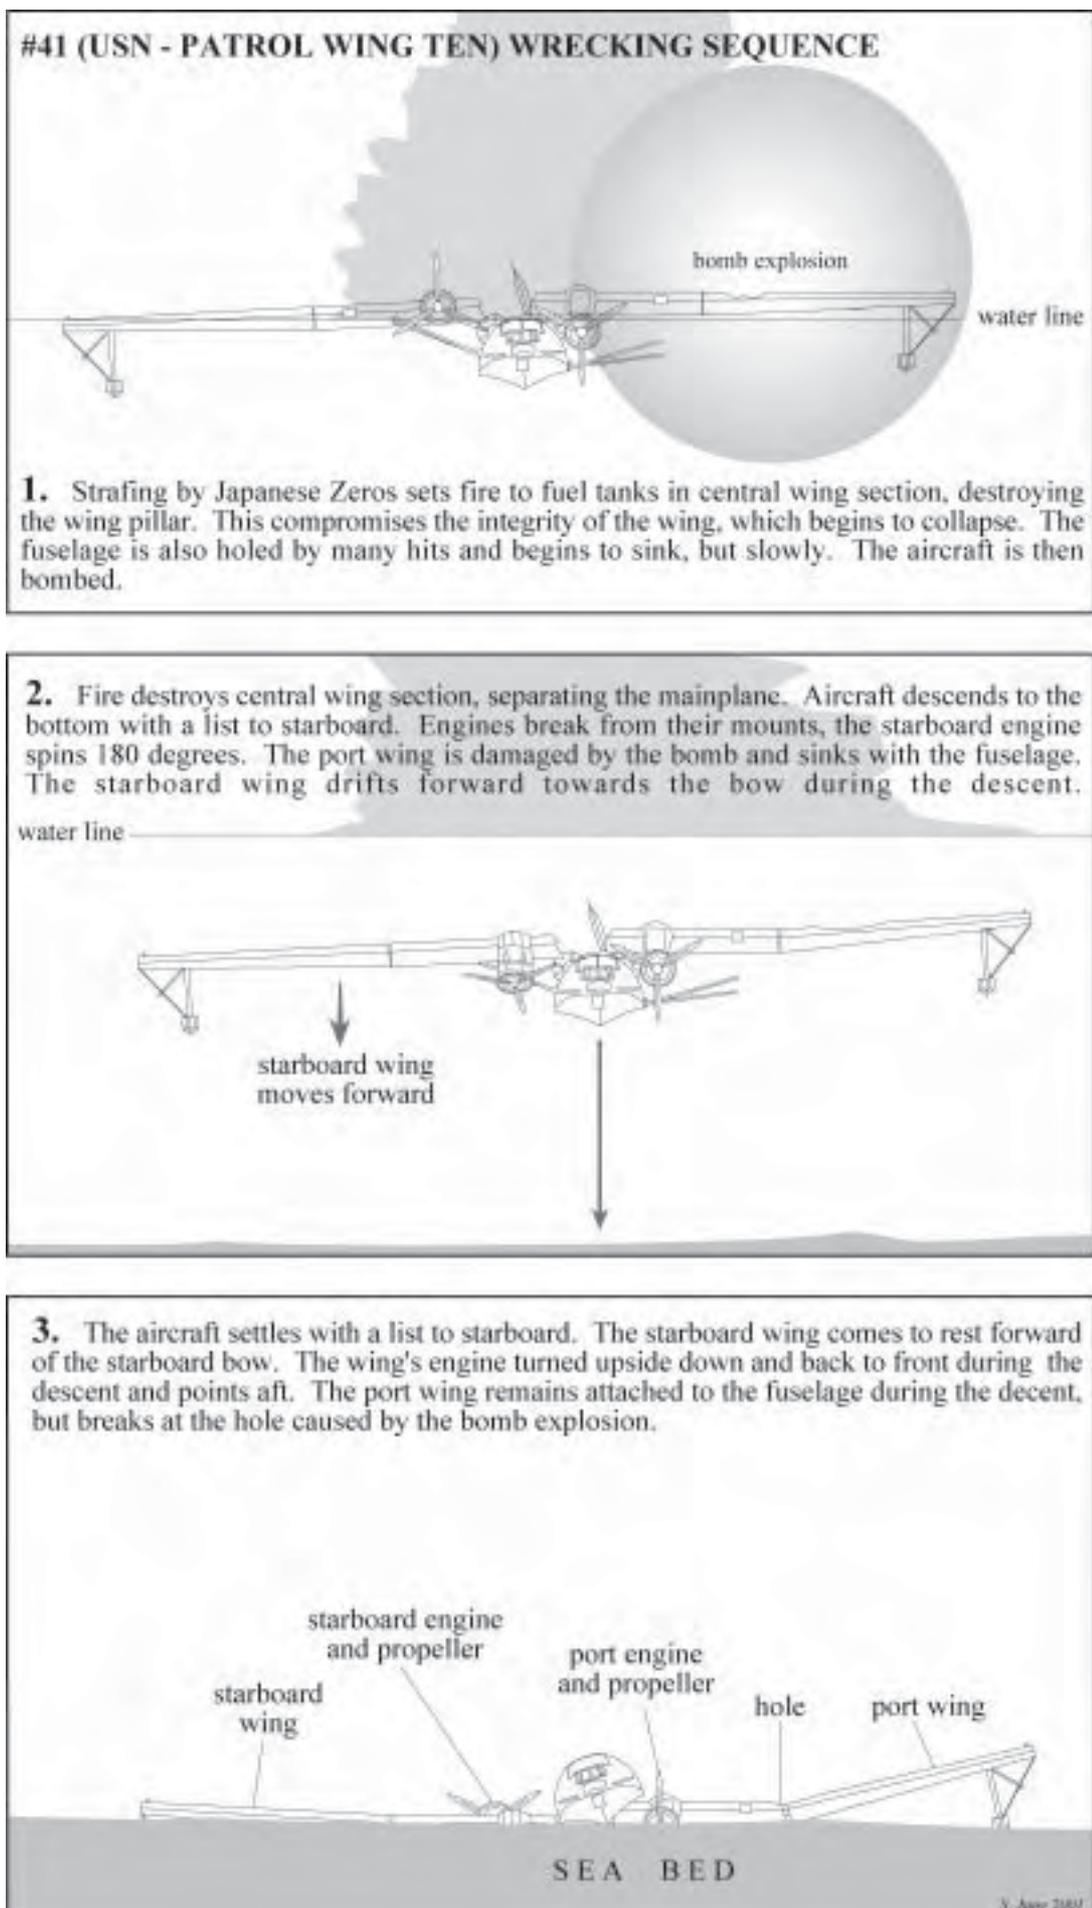
Figure 33. Wrecking sequence of Catalina 4.

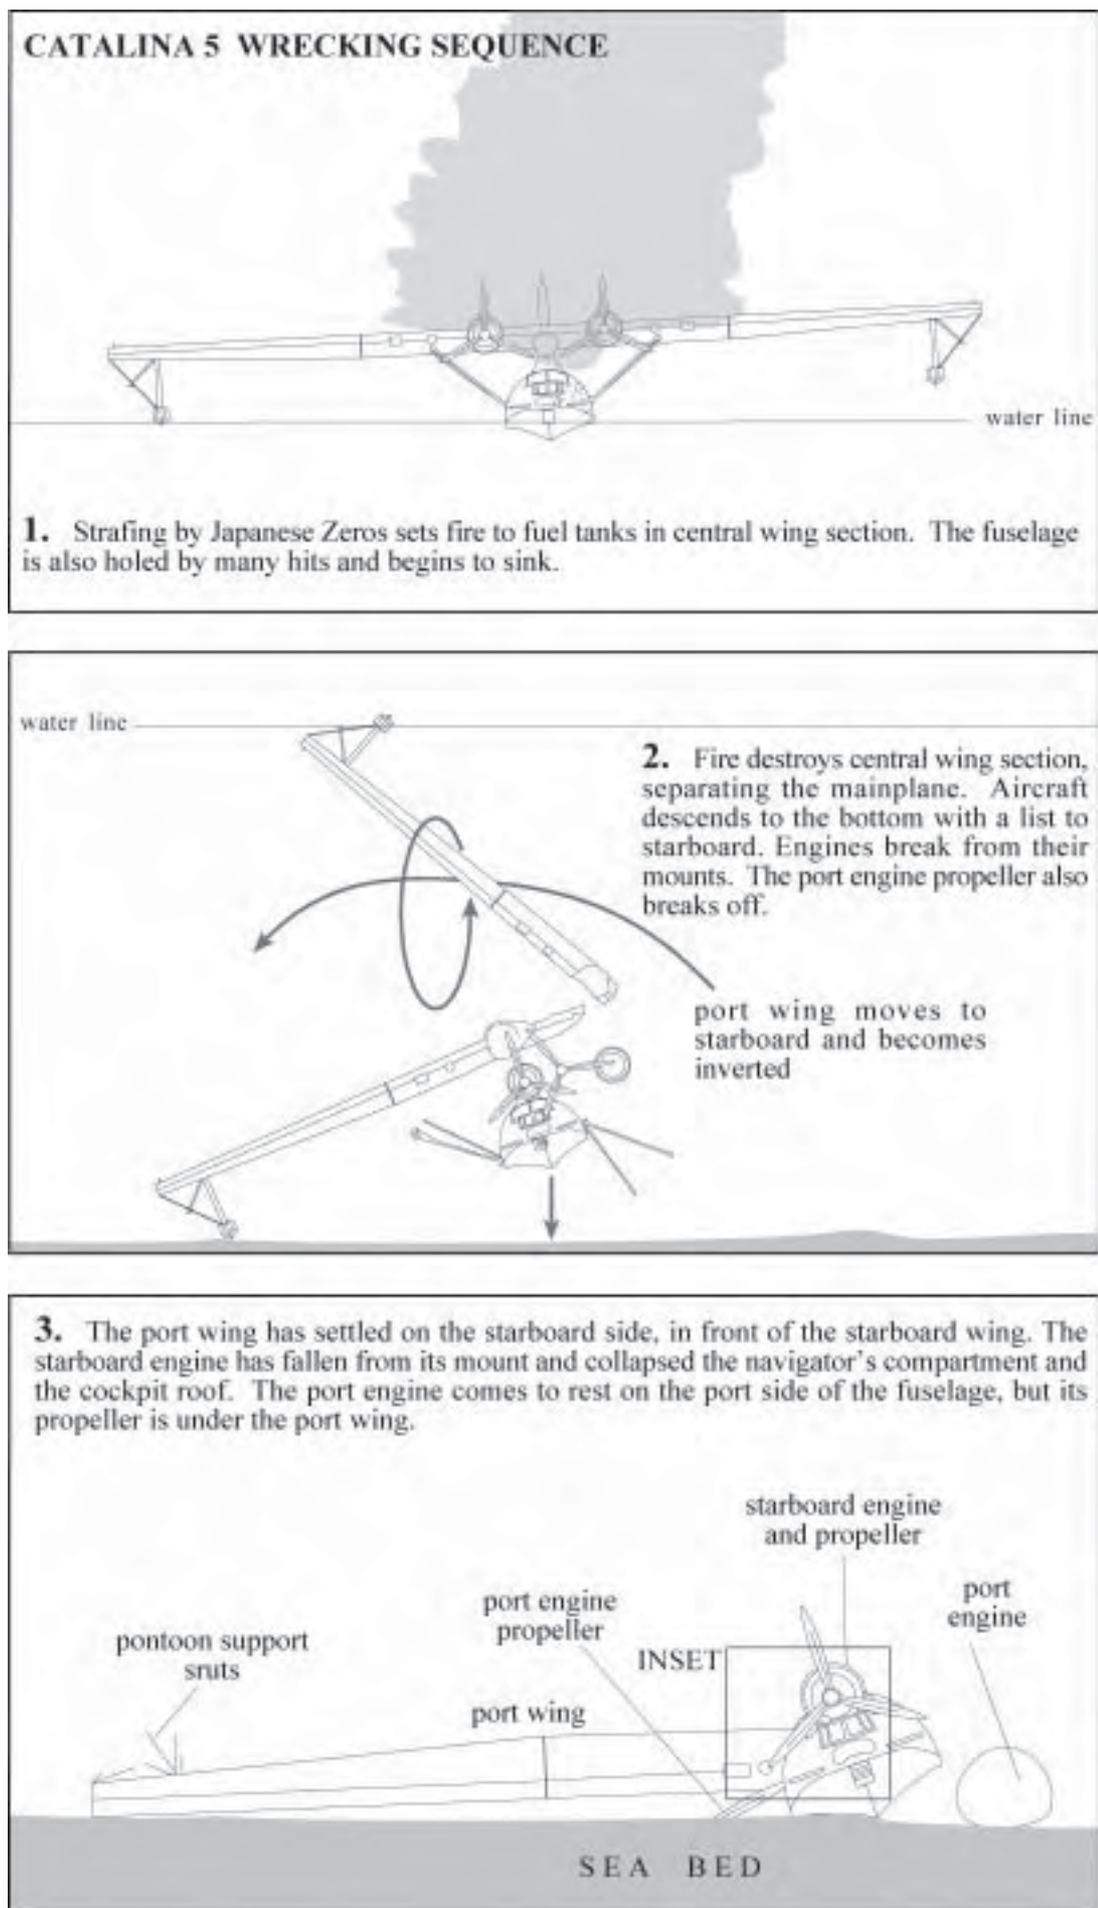
Figure 34. Wrecking sequence of Catalina 5 (see Fig. 27 for inset).

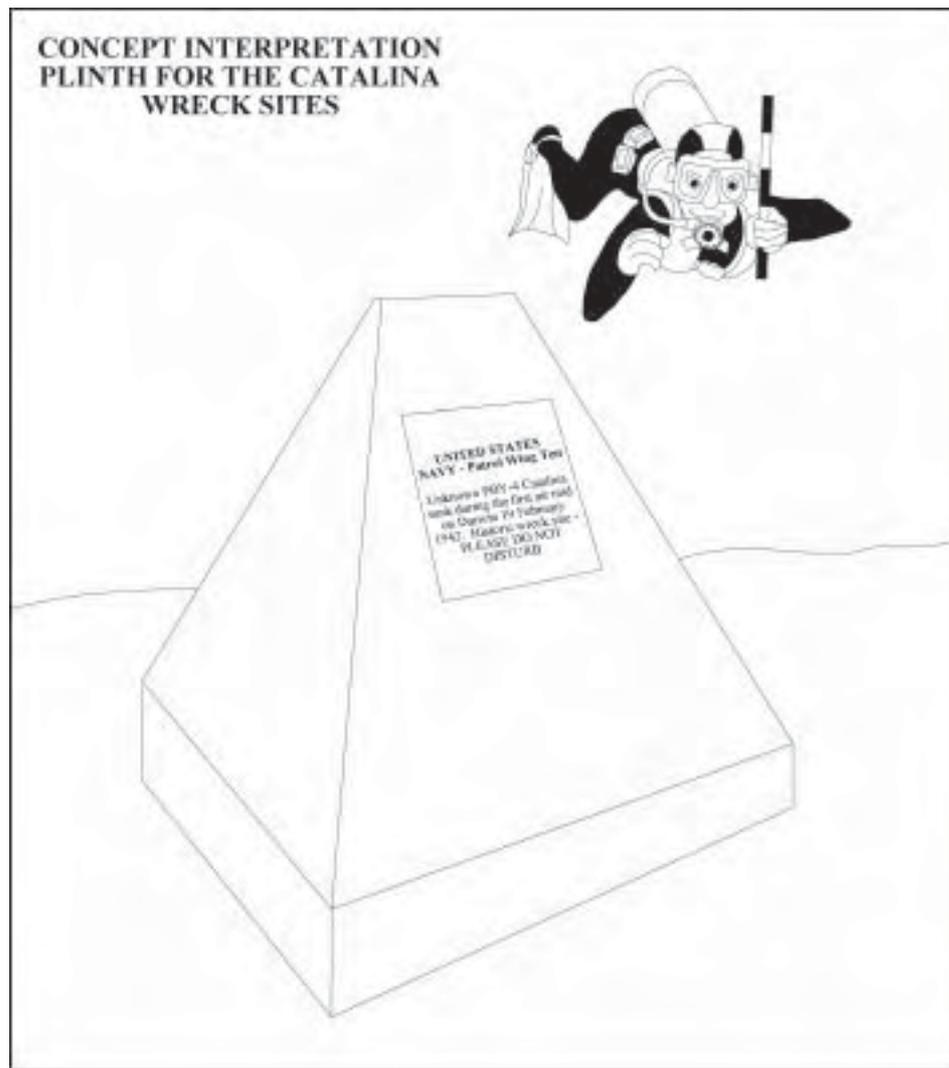
Figure 36. Concept wreck site plinth (After Dean 1988:11).
